Arboricultural Impact Assessment

Formus Miranda P/L

23 Kiora Road & 2 – 6 Willock Ave, Miranda,
NSW

Prepared on – 28/8/23

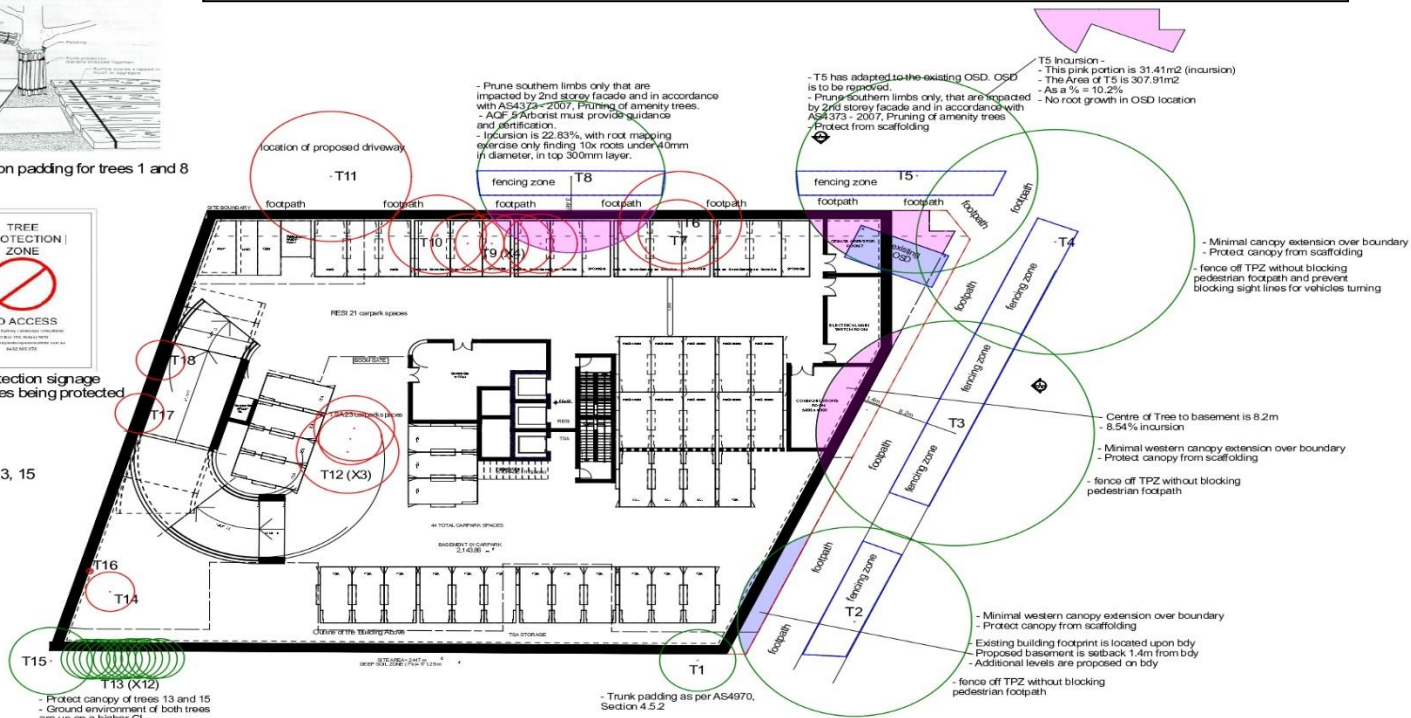
Drawing Title: **Tree Location and Protection Plan**

Tree protection fencing for trees; 2, 3, 4, 5, 8

Tree protection padding for trees 1 and 8

Scaffolding requirements as per AS4970 - 2009, Section 4.5.6

Hold points prior, during and after all works have been completed are recommended to be implemented.

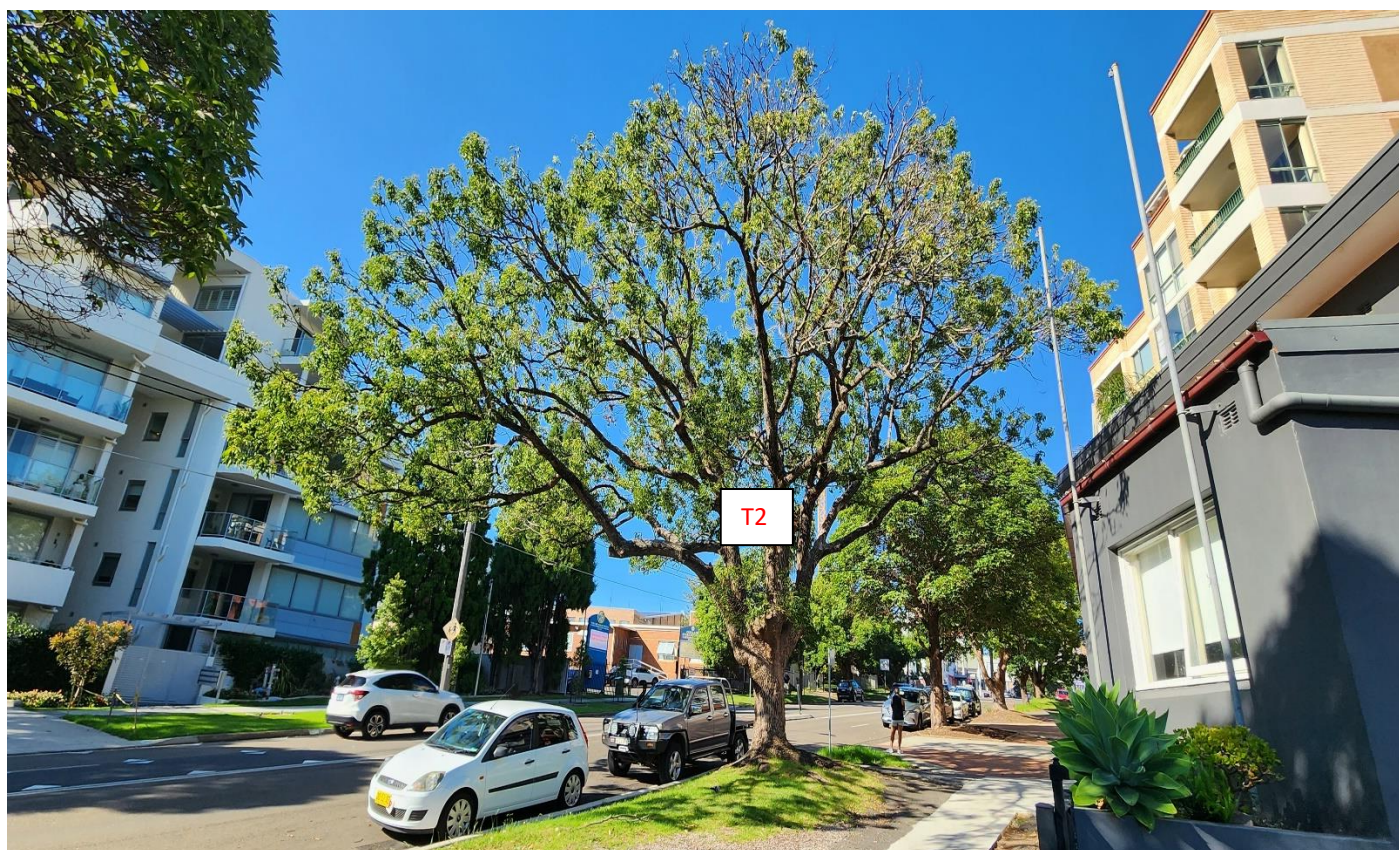
Tree 2, *Cinnamomum camphora*, has been assessed from the initial site visit as displaying of low vigour and thinning canopy. From the second site visit (18/8/23) whilst undertaking the root mapping assessment, it was observed, that this tree has declined further with an increase in thinning canopy and an increase in evidence, of possum chewing new leaf and possum faeces on the ground, under the canopy.

Photograph 8, looking South to tree 2, thinning canopy and lacking in vigour

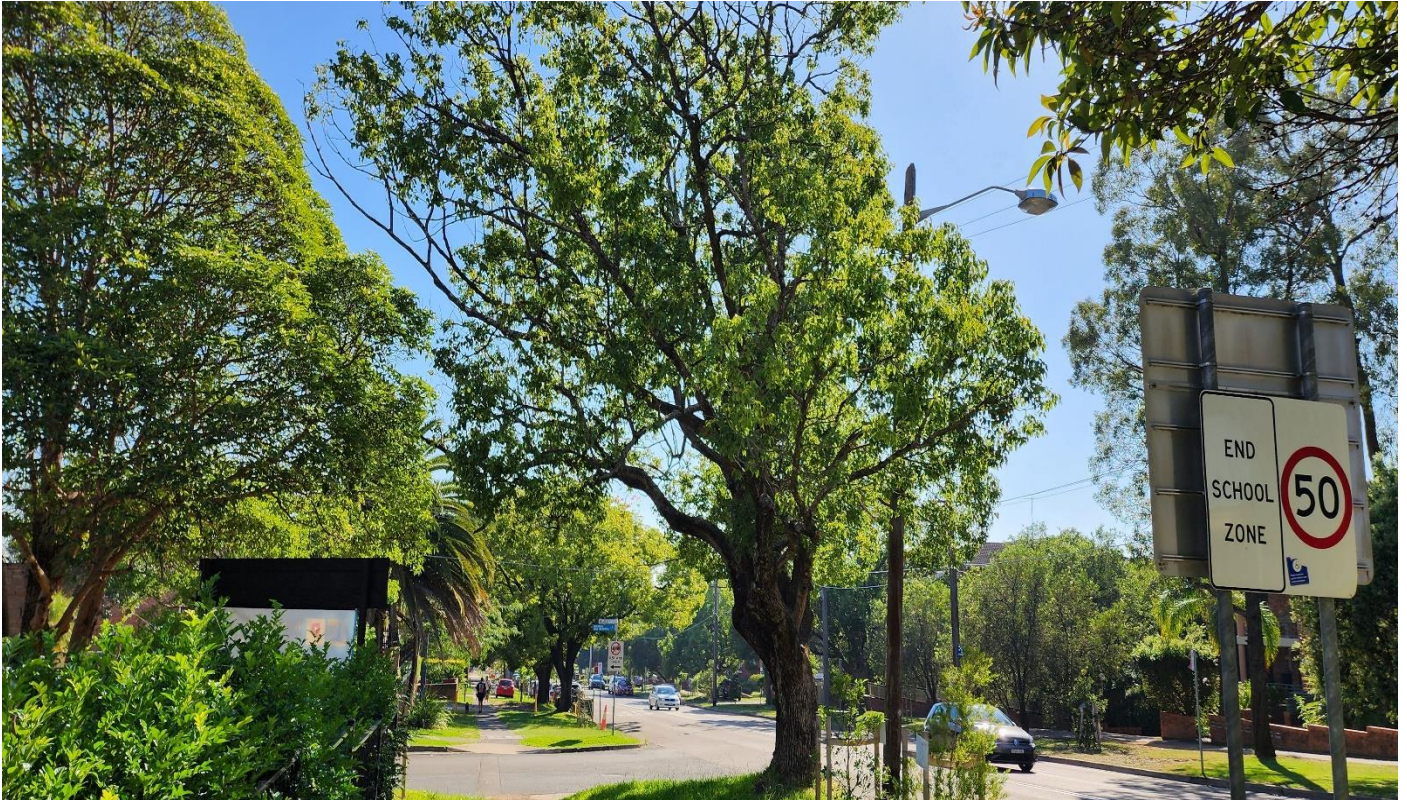
Tree 4) ***Cinnamomum camphora*** – This tree being upon Councils Street verge fronting Kiora Rd, but located close to the corner of Kiora and Willock, has a calculated TPZ of 11.4m radially out from its trunk. This tree has adapted over its lifetime with the existing OSD being located within its most Western TPZ. With this OSD being removed, the corner of the proposed building will replace this OSD incursion and constitutes a Minor encroachment. Arboricultural Hold Points and Certifications are recommended.

Photograph 9, looking North East to tree 4, in poor condition

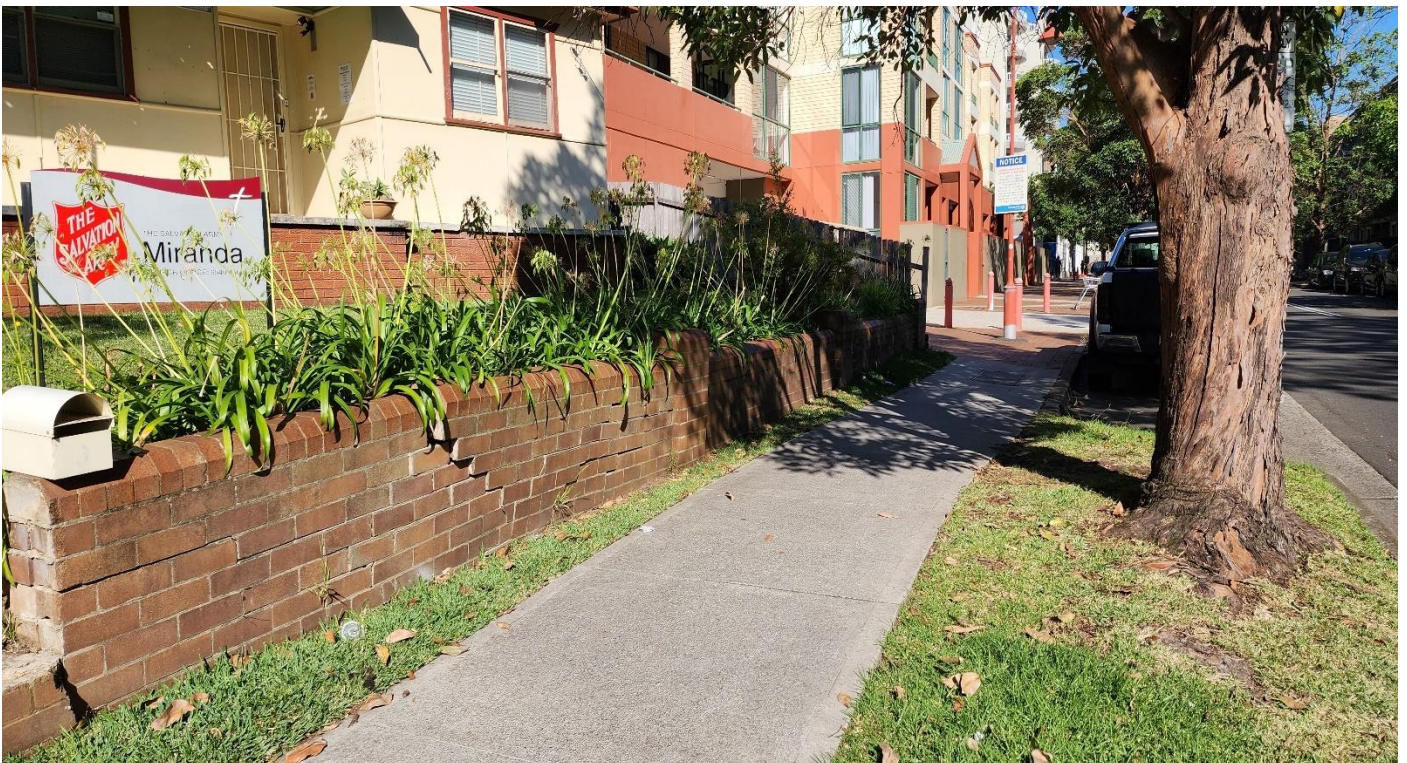
Tree 11) ***Lophostemon confertus*** – This trees location conflicts with the proposed driveway and is a total loss under this proposal. The opportunity to retain this tree and discussions with the stakeholders, decided that for the entire project to work, this location was the best option. Furthermore, the existing brick wall fronting tree 11, is severally, structurally compromised and dangerous and can be assumed that tree roots have caused this, with changing levels inside the site compared to Councils Street verge levels.

Photograph 10, looking West at boundary wall, fronting tree 11. Structurally dangerous with soil levels within site, much higher than Council verge.

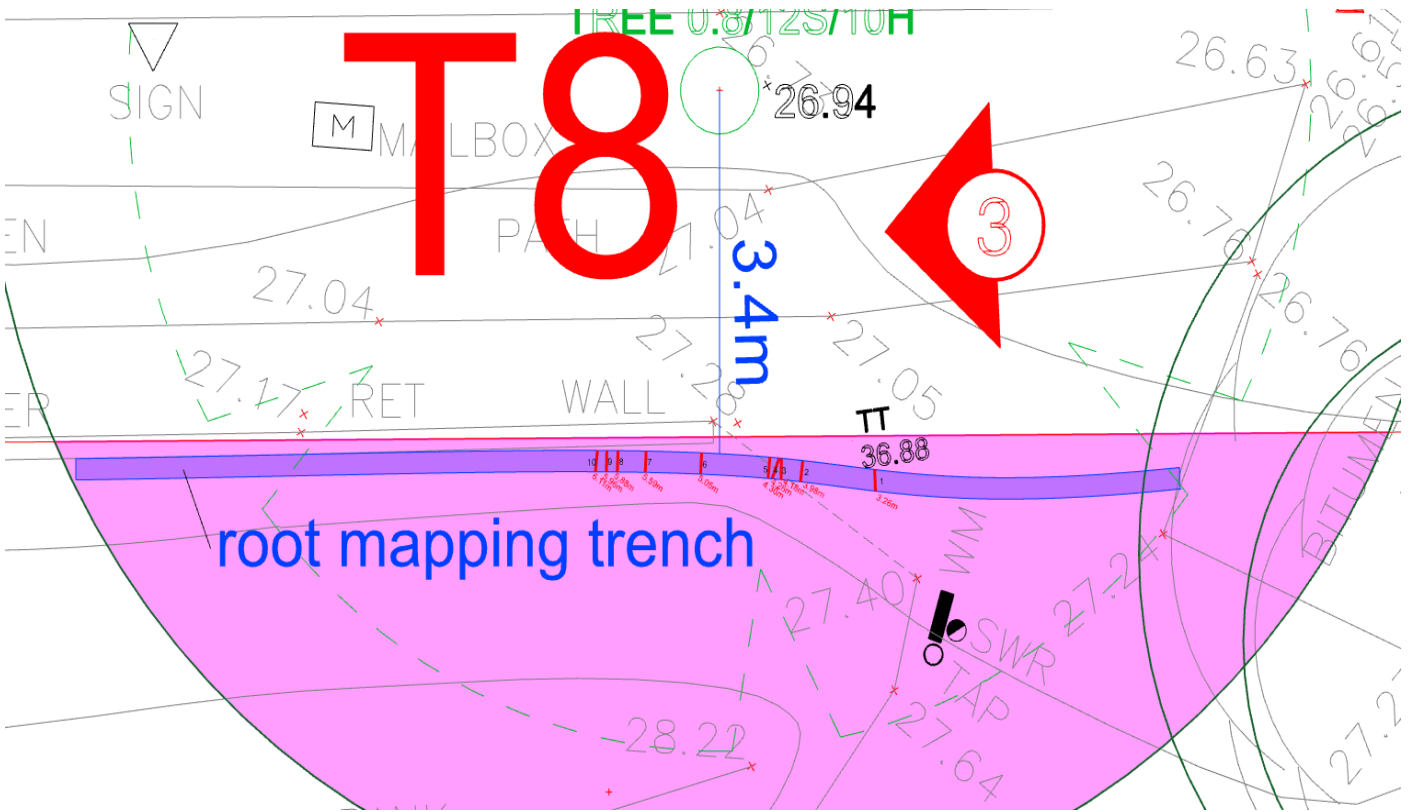
Tree 8, *Lophostemon confertus* has an approx. incursion of 24% into its TPZ of 7.7m and therefore a root mapping assessment was conducted on the 18/8/23. A total of 10x roots have been exposed in depths of 300mm, that constituted impregnable soil and hard pan clay. (See Appendix 10.5)

Tree 8) ***Lophostemon confertus*** – On plan, the incursion from the basement upon the boundary is approx. 24% and this constitutes a major incursion. Root mapping was undertaken on the 18/8/23, upon the boundary and approx. 10x roots have been found at depths of 300mm at no larger diameters of 40mm. As mentioned in this report, the Air spade utilised, had difficulties in penetrating further than 300mm, subsequently and not at the expense of destroying and delaminating existing roots, deeper excavations proved futile.

The soils found in the location of trenching, demonstrated as hard, compacted, relatively moist and somewhat undisturbed. The Air spade encountered difficulties in obtaining depths greater than 300mm. This was a concern, due to the impenetrable soils and impacts to existing roots and possible delamination of such roots.

No roots over 40mm were found within the trenching performed.

Root Mapping alignment above, fronting T8

The Author of this report recommends that any roots pruned are to be done prior to any construction activities. Hand tools will be necessary to expose the roots found within this root mapping exercise. The roots are to be pruned by an Arborist using a sharp sterilised saw behind the cut face, perpendicular to root travel, prior to being backfilled with clean site soil.

The soil and surrounds are to be immediately irrigated. The cut face is to be covered with woven geofabric material and pegged into place to prevent contamination. Irrigate the area surrounding the tree at least twice per week (if required). Apply *Seasol* at the rate prescribed on the label for a 'stressed' tree. *Seasol* is a seaweed concentrate tonic, that is found to stimulate root growth and give better resistance to fungal attack.

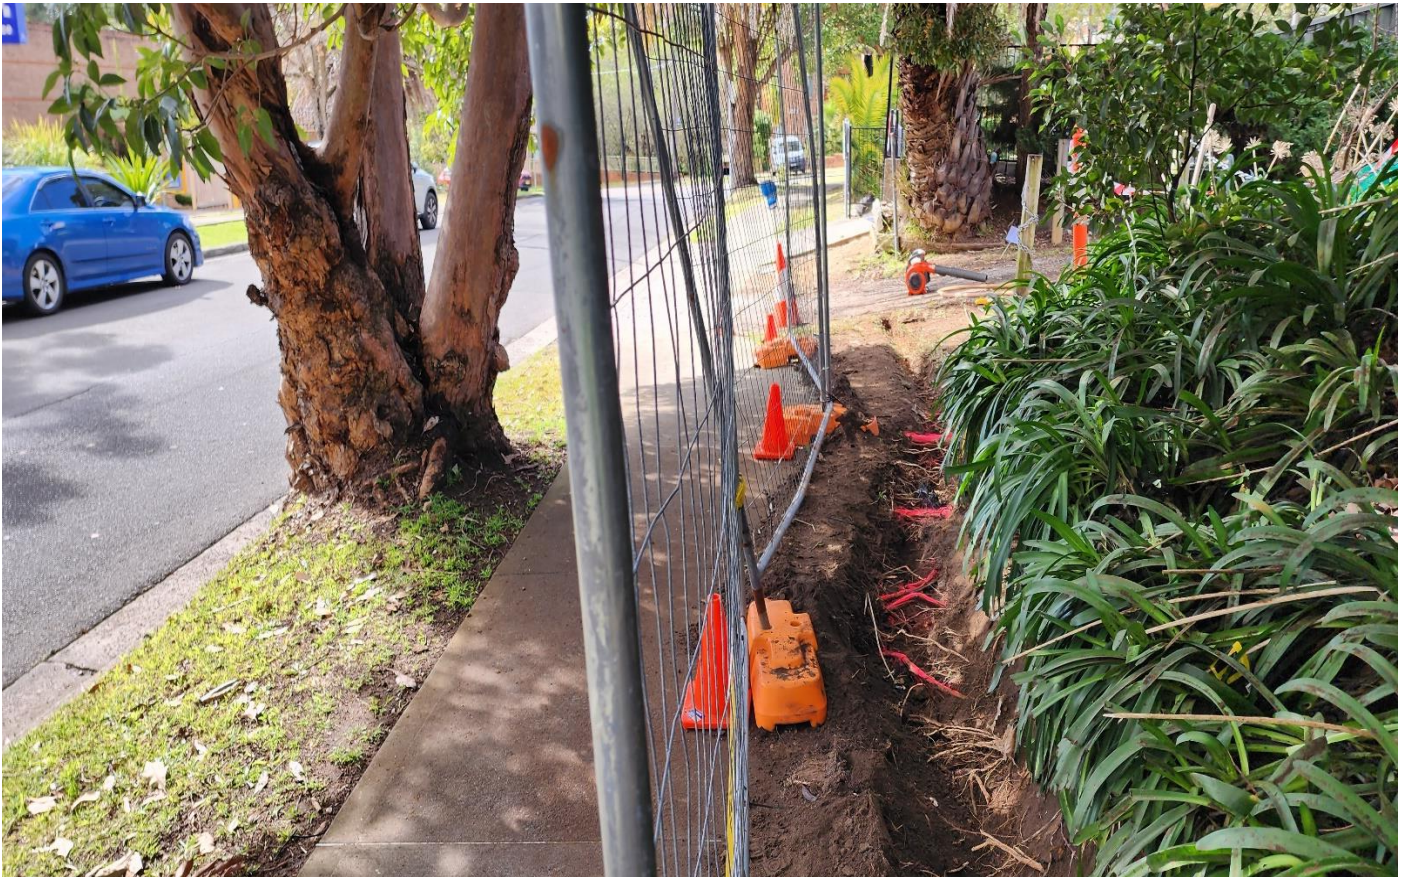
Photograph 1 above looking East to the open trench

Many fibrous roots were found close to the starting point A, and these were identified as being from the *Phoenix canariensis*, several metres to the East and seen within photographs.

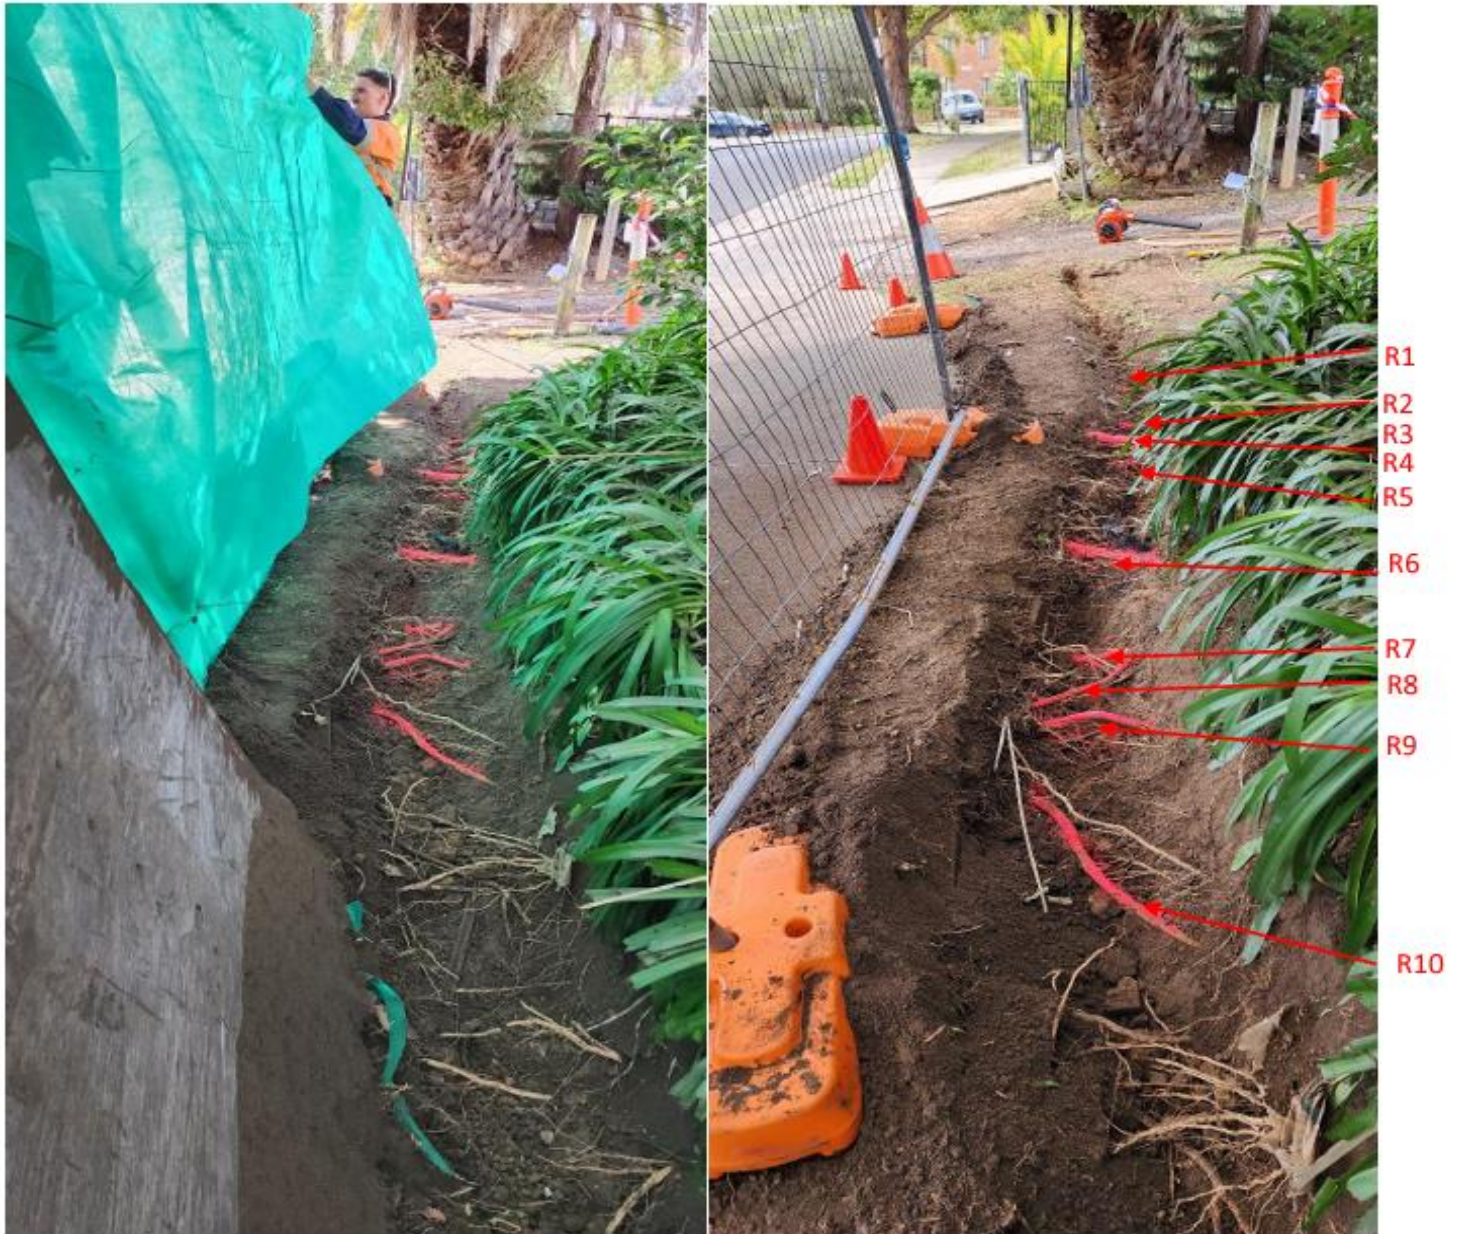
Photographs 2, left, above looking East to the open trench. Many fibrous *Murraya* roots in the foreground.
