# pre-development tree assessment

## PDTA-01

Revision A, Issued for Information, 30.10.2019

## Cronulla Town Centre Upgrade - Stage 2

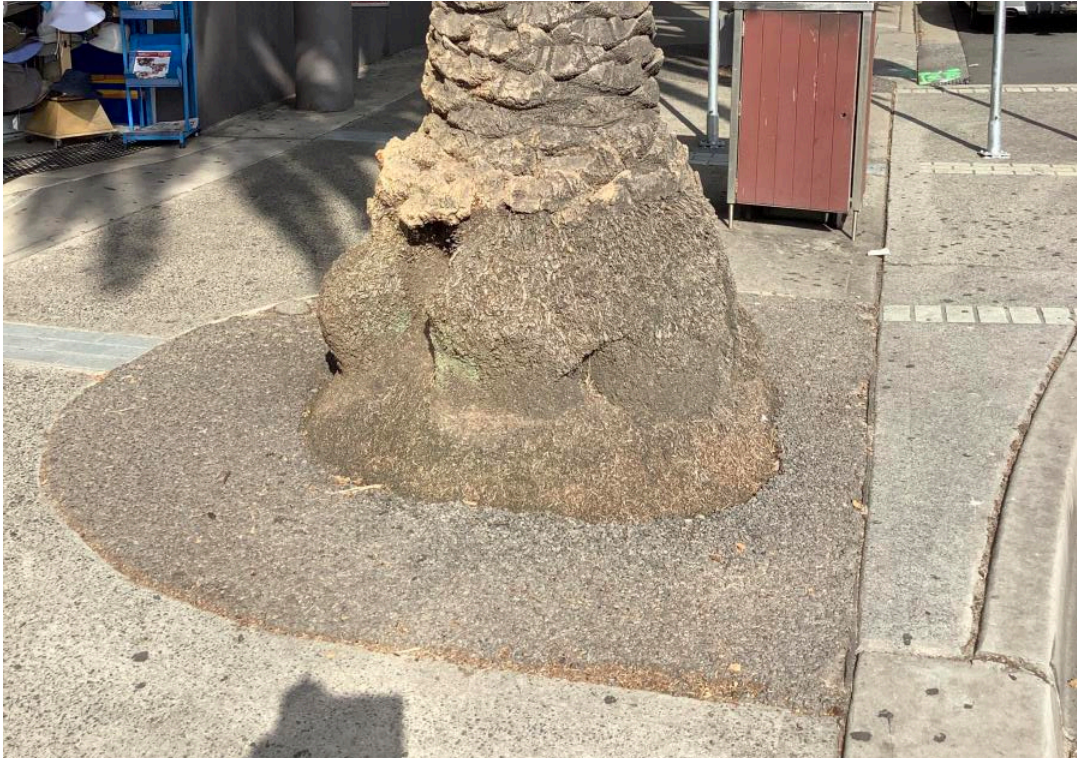
The palms adjacent to Kingsway are typically growing within small semi-circular kerbside planting pits, approximately 1.5m diameter, with less than a metre from the base of the trunk to the back of the road side kerb. These pits are typically topped with permeable resin-bonded paving. The palms do make a noticeable and significant contribution to the landscape character at this part of Cronulla. Given the limited space, harsh growing conditions and the exposed location they do provide a sizable and hardy solution to street tree planting.

Figure 5 – View of typical palm surround along Kingsway. (Photo: Arterra 16.10.19)

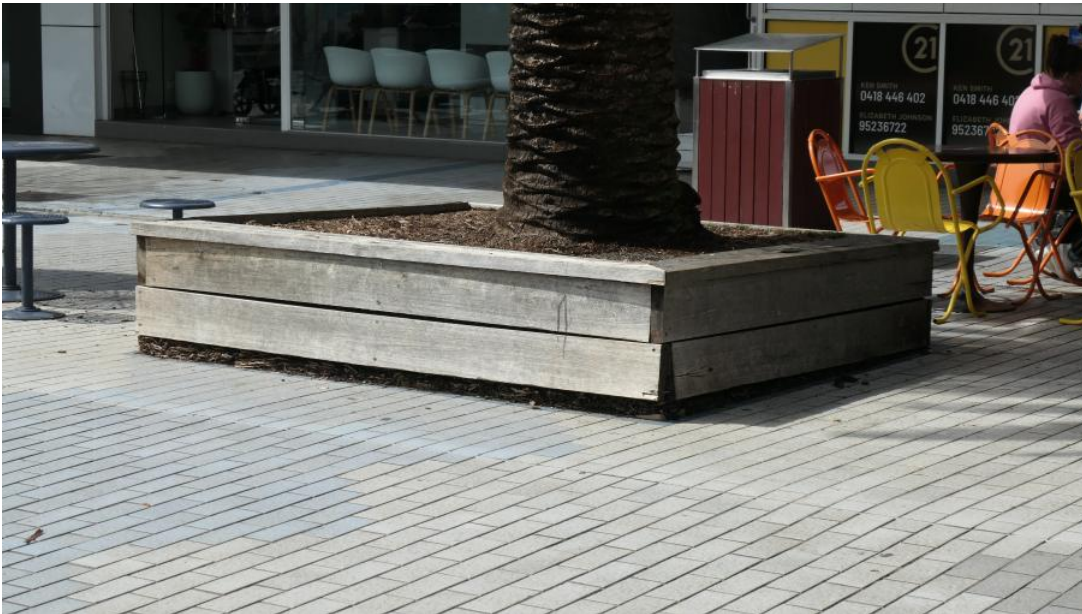
Figure 8 – View of the Phoenix palms at the southern end of the Mall where they have been planted within a raised timber surround. Roots are readily seen around the edges and are lifting the timberwork above the pavement. This is symptomatic of a tree with limited soil volume and indicating that the root mass has most likely fully exhausted the available soil resources and now expanding in the only way it can. (Photo: Arterra 19.9.19)

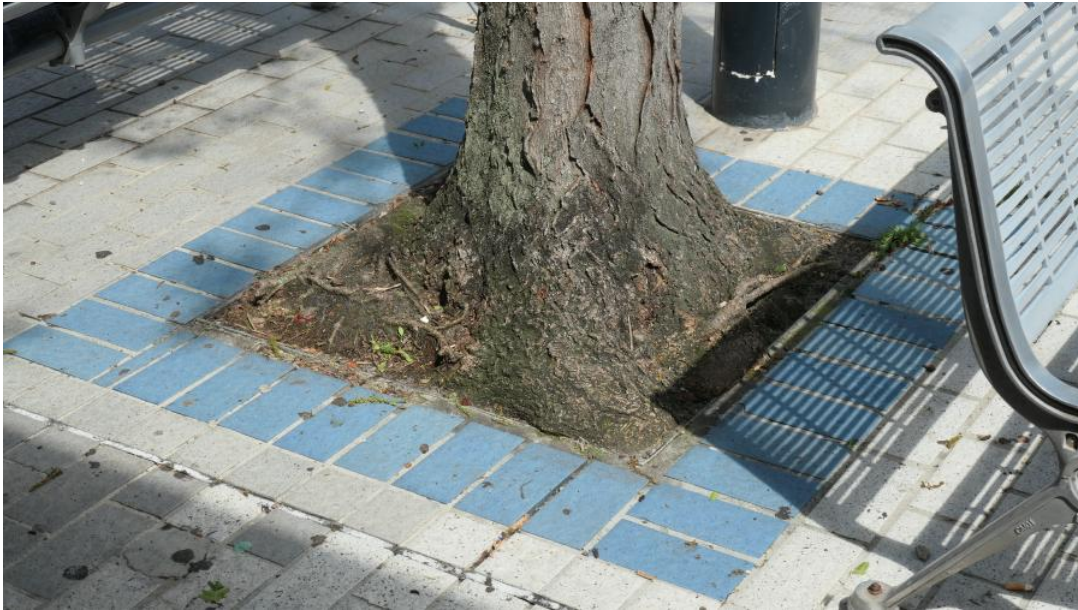
Figure 9 – View of typical tree surround in the Mall. Note that the tree root flare has now typically fully occupied the space between the pavement and around the tree. Further root flare development is extremely limited. (Photo: Arterra 16.10.19)

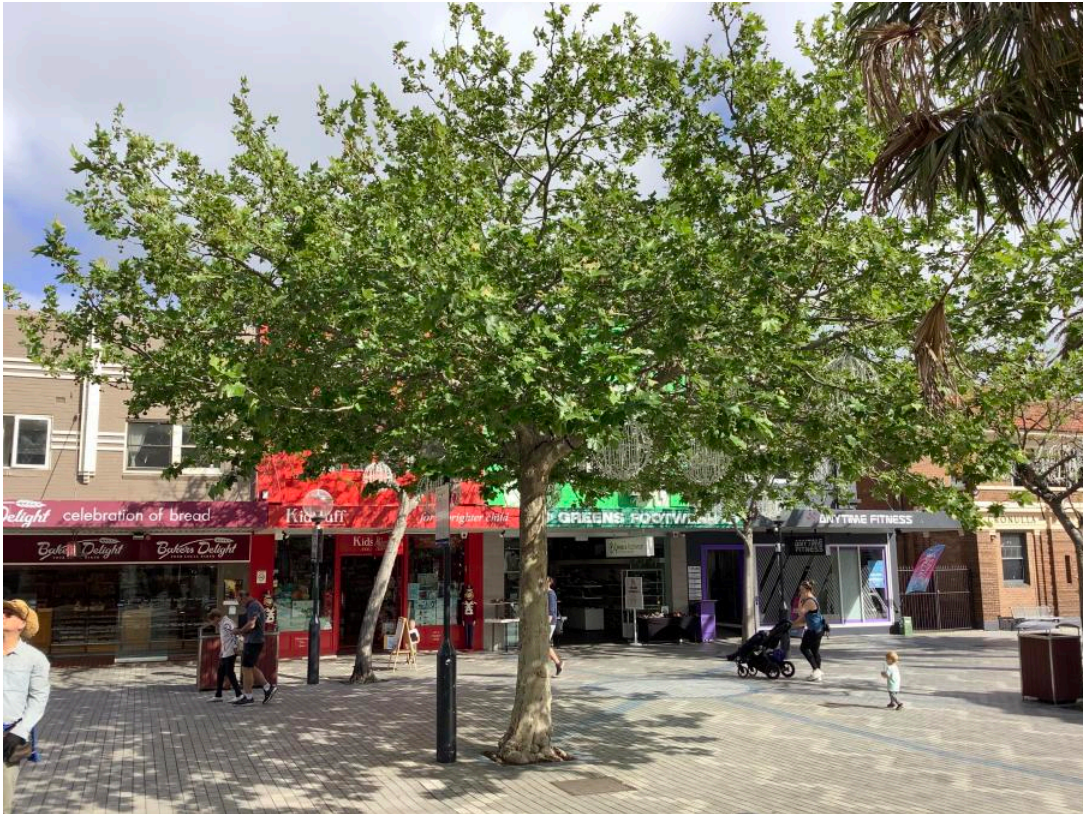
Figure 10 – Despite being one of the better trees in the Mall, this London Plane (T25) is very stunted and not really contributing to the Mall in a way that should be expected from a 3-0-40 year old tree. (Photo: Arterra 16.10.19)

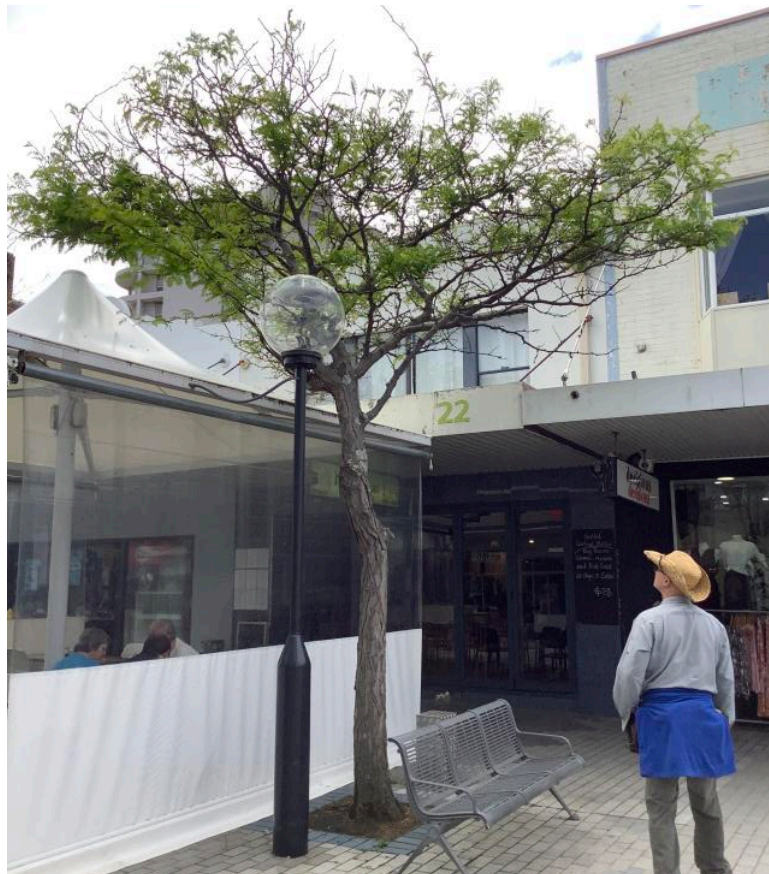
Figure 11 – A typical tree within the Mall. Given the age of the tree this tree should be considered woefully inadequate as it provides little in the way of shade or amenity. Although it may survive for some years, it is our opinion that it should be removed as part of the upgrade in favour of new tree planting that is provided with significantly improved subsurface growing conditions (Photo: Arterra 16.10.19)

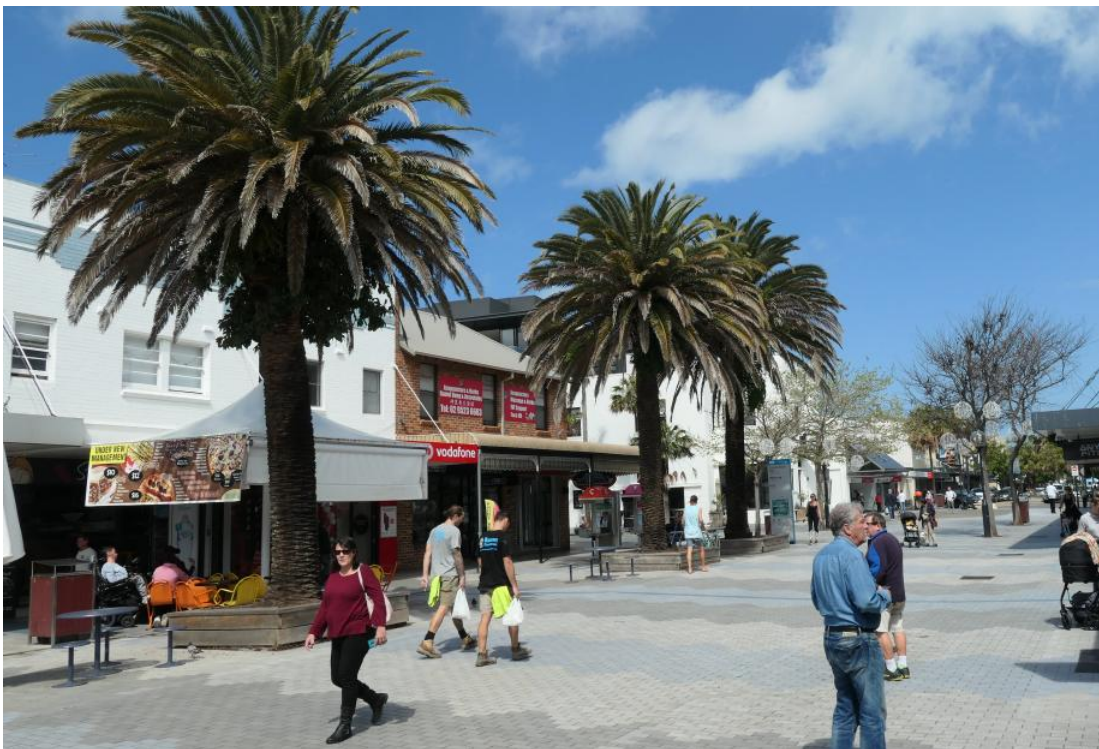
Figure 13 – Cronulla Mall, southern end, view southeast, three of the better-looking *Phoenix canariensis* (Canary Island Date Palm). These could be transplanted to a new location within or near the Mall to facilitate the proposed upgrades and provide better and longer term health and vigour for these palms into the future. (Photo: Arterra 19.09.19)

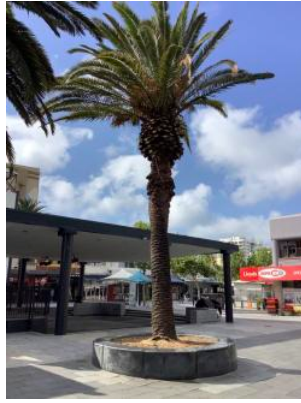
ID # 17  
Species: *Phoenix canariensis*  
Common: Canary Island Date Palm  
Height (m): 5.4  
DBH (m): 0.52 DGL (m): 0.87  
Current Form: Good  
Current Vigour: Poor  
Age Class: Mature  
SULE: Remove (<5 years)

Retention Value: **Low**

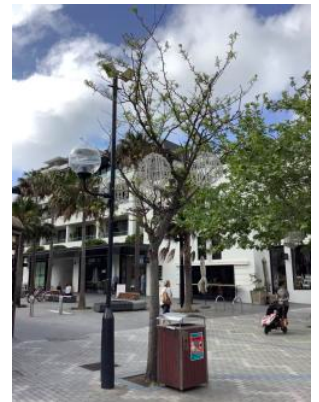
ID # 24  
Species: *Gleditsia triacanthos* 'Shademaster'  
Common: Honey Locust  
Height (m): 6.0  
DBH (m): 0.19 DGL (m): 0.28  
Current Form: Poor  
Current Vigour: Fair  
Age Class: Mature  
SULE: Long (>40 years)

Retention Value: **Low**

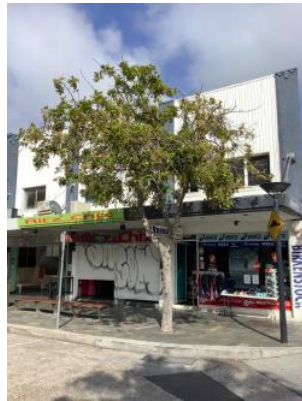
ID # 27  
Species: *Cupaniopsis anacardioides*  
Common: Tuckeroo  
Height (m): 6.2  
DBH (m): 0.22 DGL (m): 0.31  
Current Form: Average  
Current Vigour: Poor  
Age Class: Mature  
SULE: Short (5-15 years)

Retention Value: Low
