Sutherland Shire Council

Cronulla Town Centre Design Stage 2

Geotechnical Investigation and Waste Classification Report

August 2019

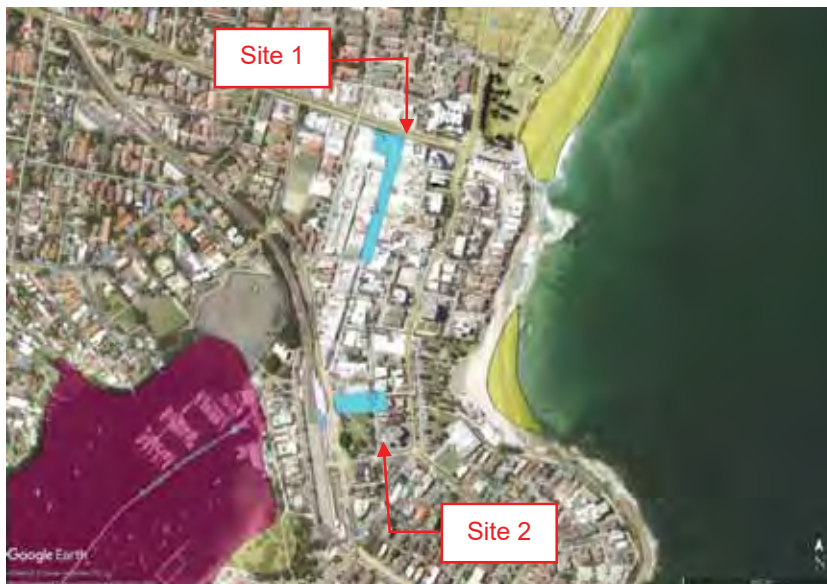
Figure 1: Acid Sulfate Soil risk map

With reference to the NSW Government Sharing and Enabling Environmental Data (SEED) website, there is no known occurrence of Acid Sulfate Soils (ASS) at the sites (aqua shading). Low risk ASS (yellow shading) is mapped approximately 150 m north east of Site 1; and high risk ASS (red shading) is mapped approximately 140 m west of Site 2.

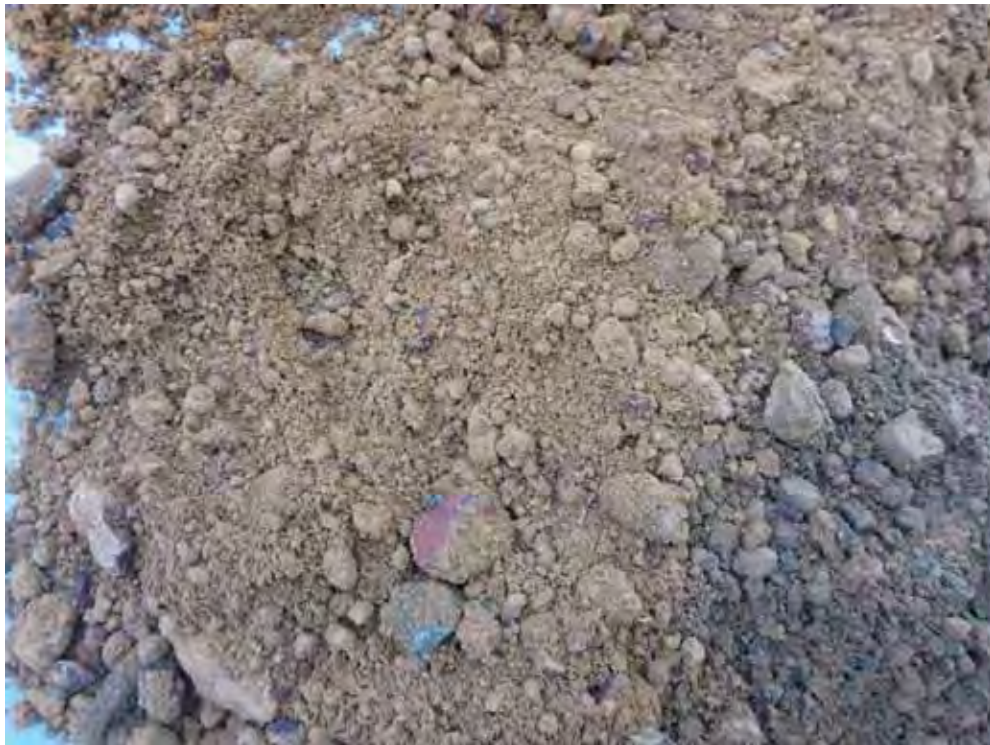
Photo 5 Silty gravel encountered at borehole BH26 between 0.20 m and 0.65 m (2/7/2019).

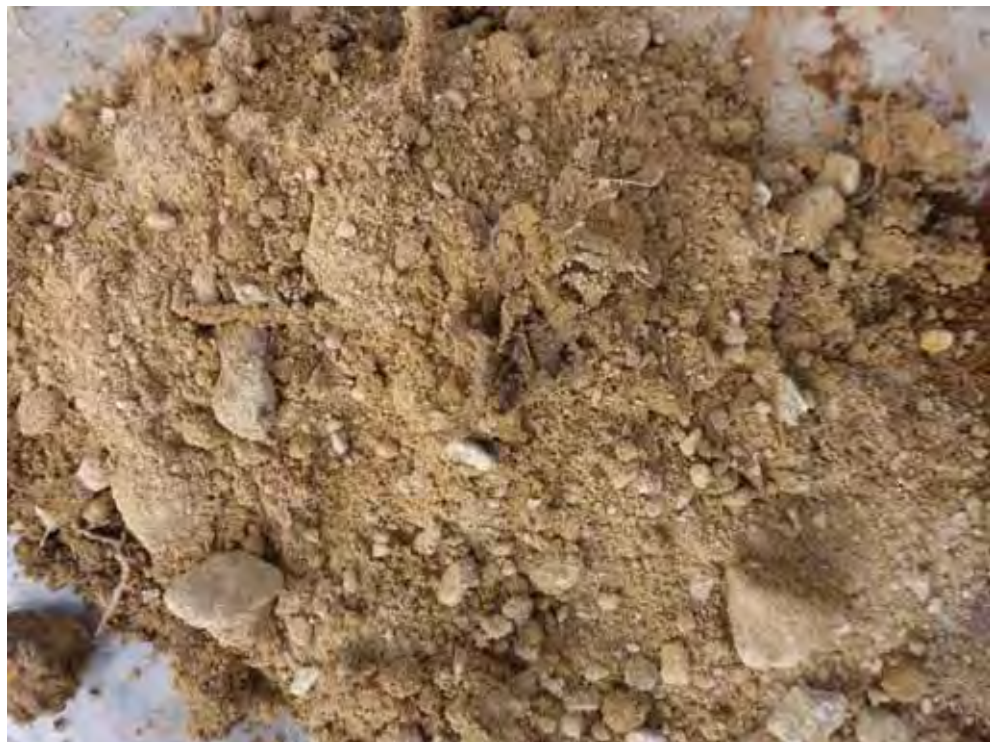
Photo 6 Gravelly sand fill material encountered at borehole BH32 between 0.22 m and 0.35 m (2/7/2019).

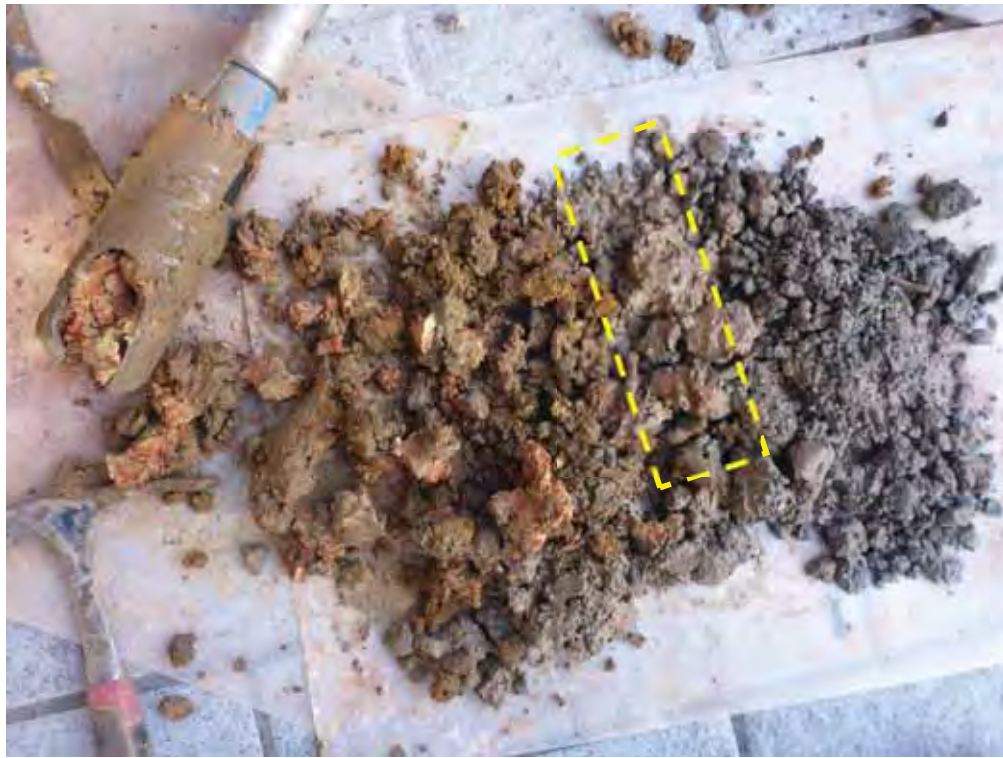
Photo 7 Subsurface conditions encountered at borehole BH12 between 0.16 m (grey on right) and 1.3 m (clay on left). Sample collected for this waste classification represented soil within the yellow outline (3/7/2019).

An indistinct odour was noted at BH12 at 0.35 m. A sample from this depth was analysed for volatile and semi-volatiles analytes.

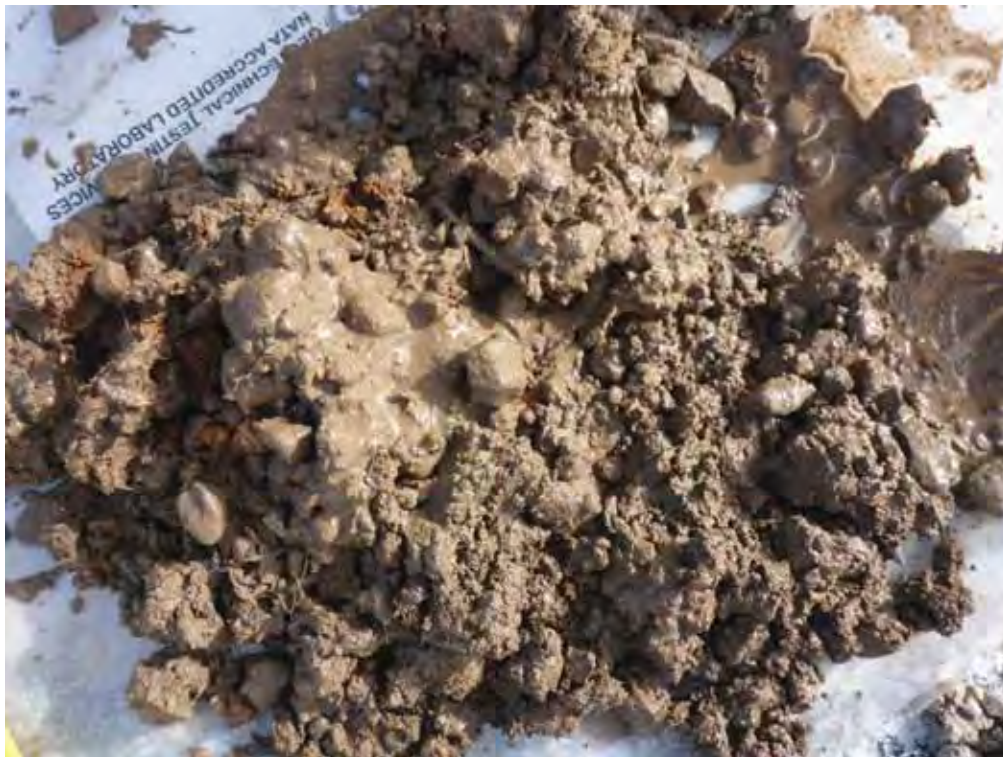
Photo 8 Gravelly sand fill at BH29 between 0.27 m and 0.65 m (2/7/2019).

- Holding times: samples were received and analysed by the laboratory within recommended holding times of 14 days. However, the TCLP analysis for PAH on sample BH29/0.3-0.45 was carried out 13 days outside of the recommended holding time. The laboratory was requested to perform a repeat analysis for PAH on this sample. The repeat results were similar to those reported within holding time, where RPDs were between 10% and 20% for Total PAH and Benzo(a)Pyrene, respectively. Based on this result, it is considered that the TCLP result for PAHs are representative to the soil conditions at the time of sampling.
