SITE AUDIT REPORT

**251 & 280-282 Captain Cook Drive,
Kurnell NSW**

Prepared for: Besmaw Pty Ltd

Audit Number: JE105

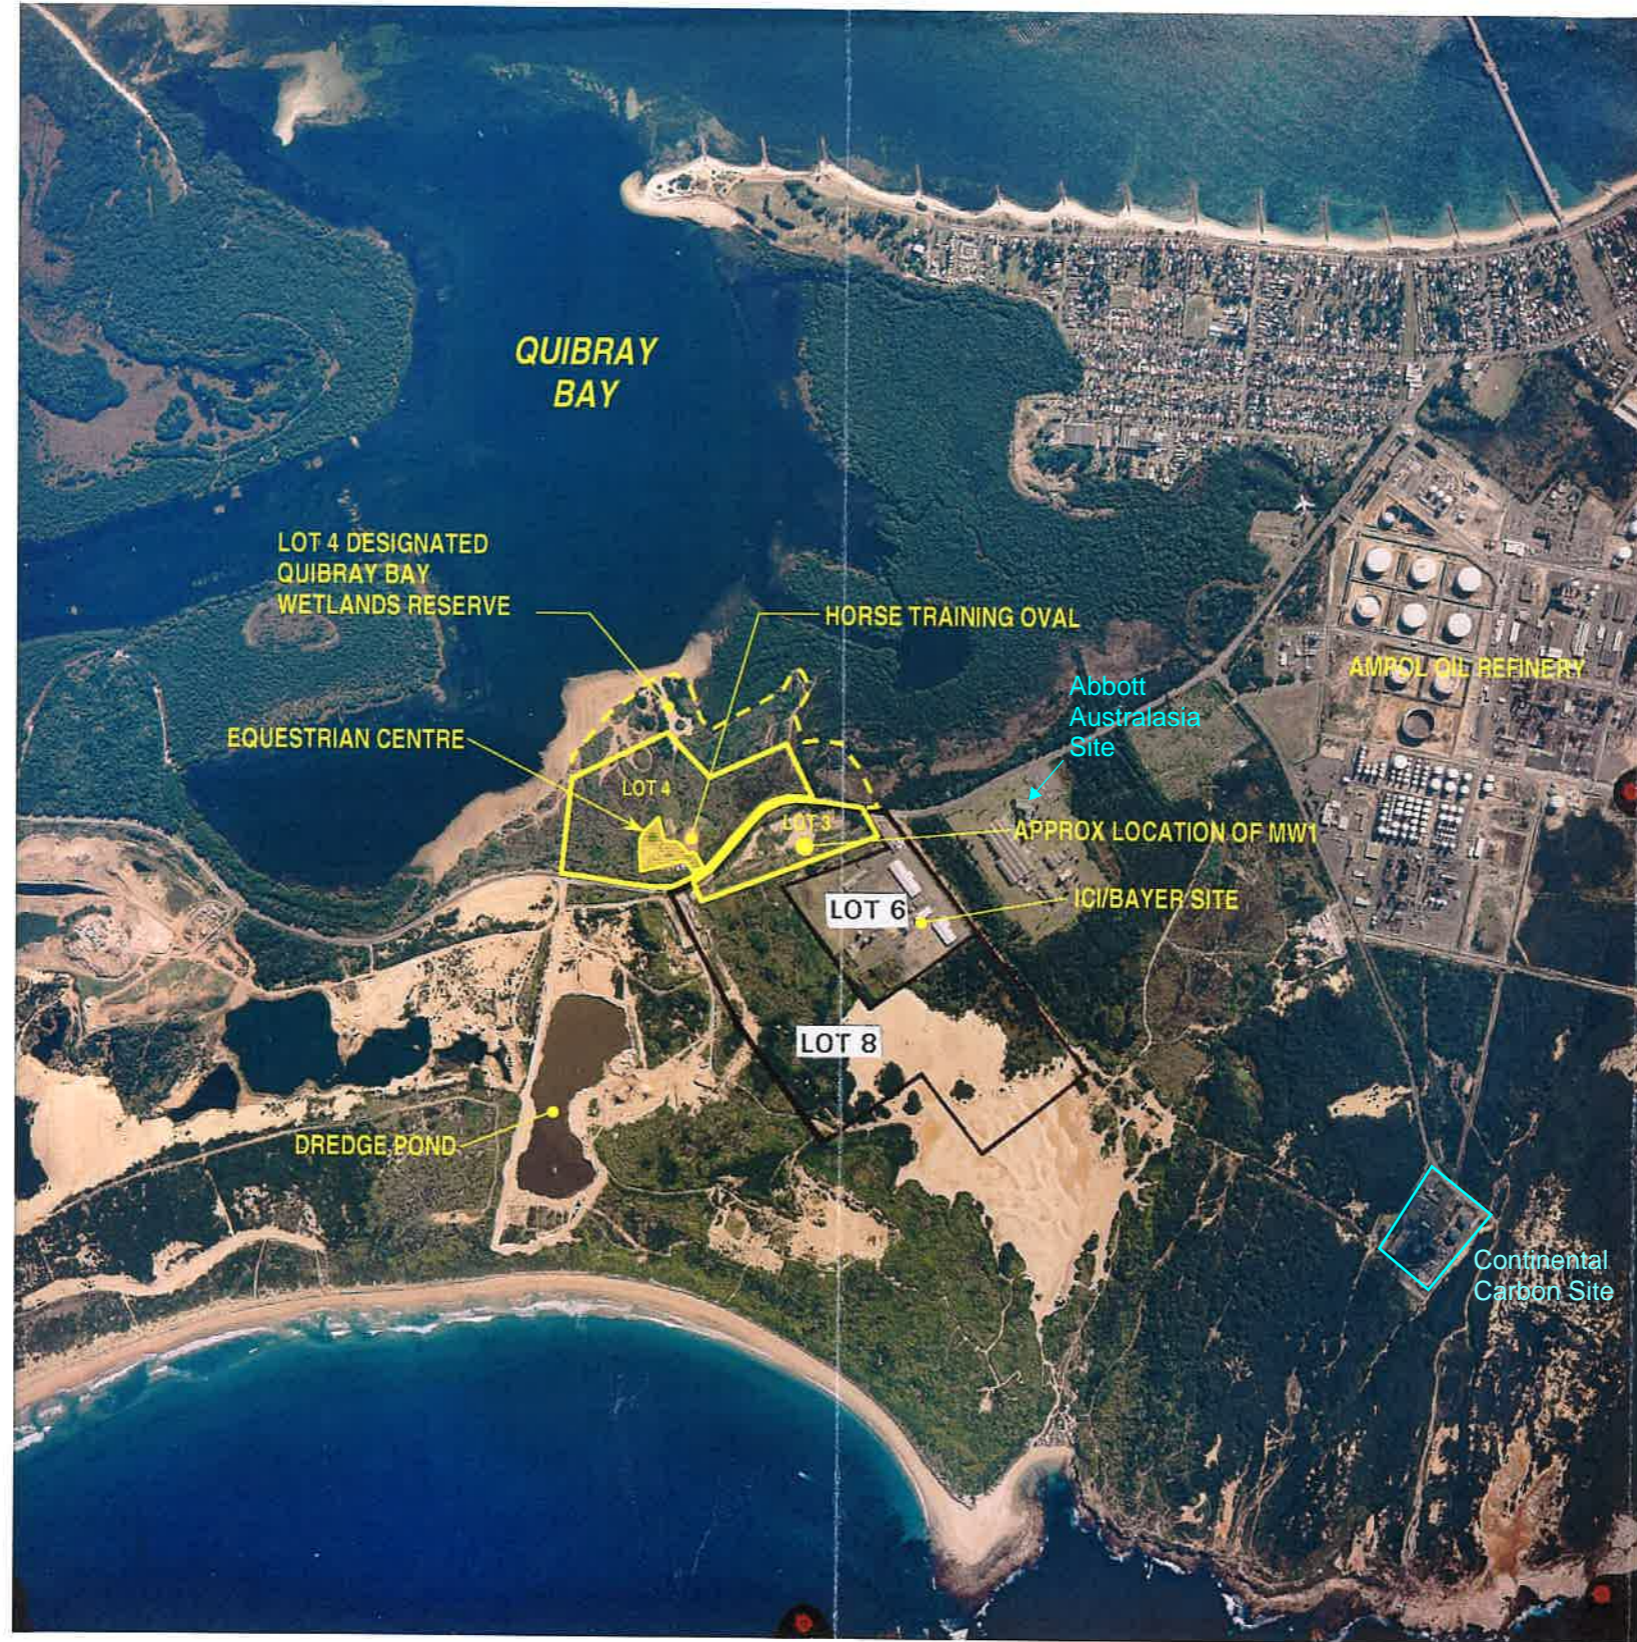
| Drawn | KME/SW | BESMAW PTY LTD PRELIMINARY ENVIRONMENTAL SITE ASSESSMENT | FIGURE 2 |

NOTE: Abbot Australasia and Continental Carbon site locations added by the auditor based on review of site history information in June 2023.

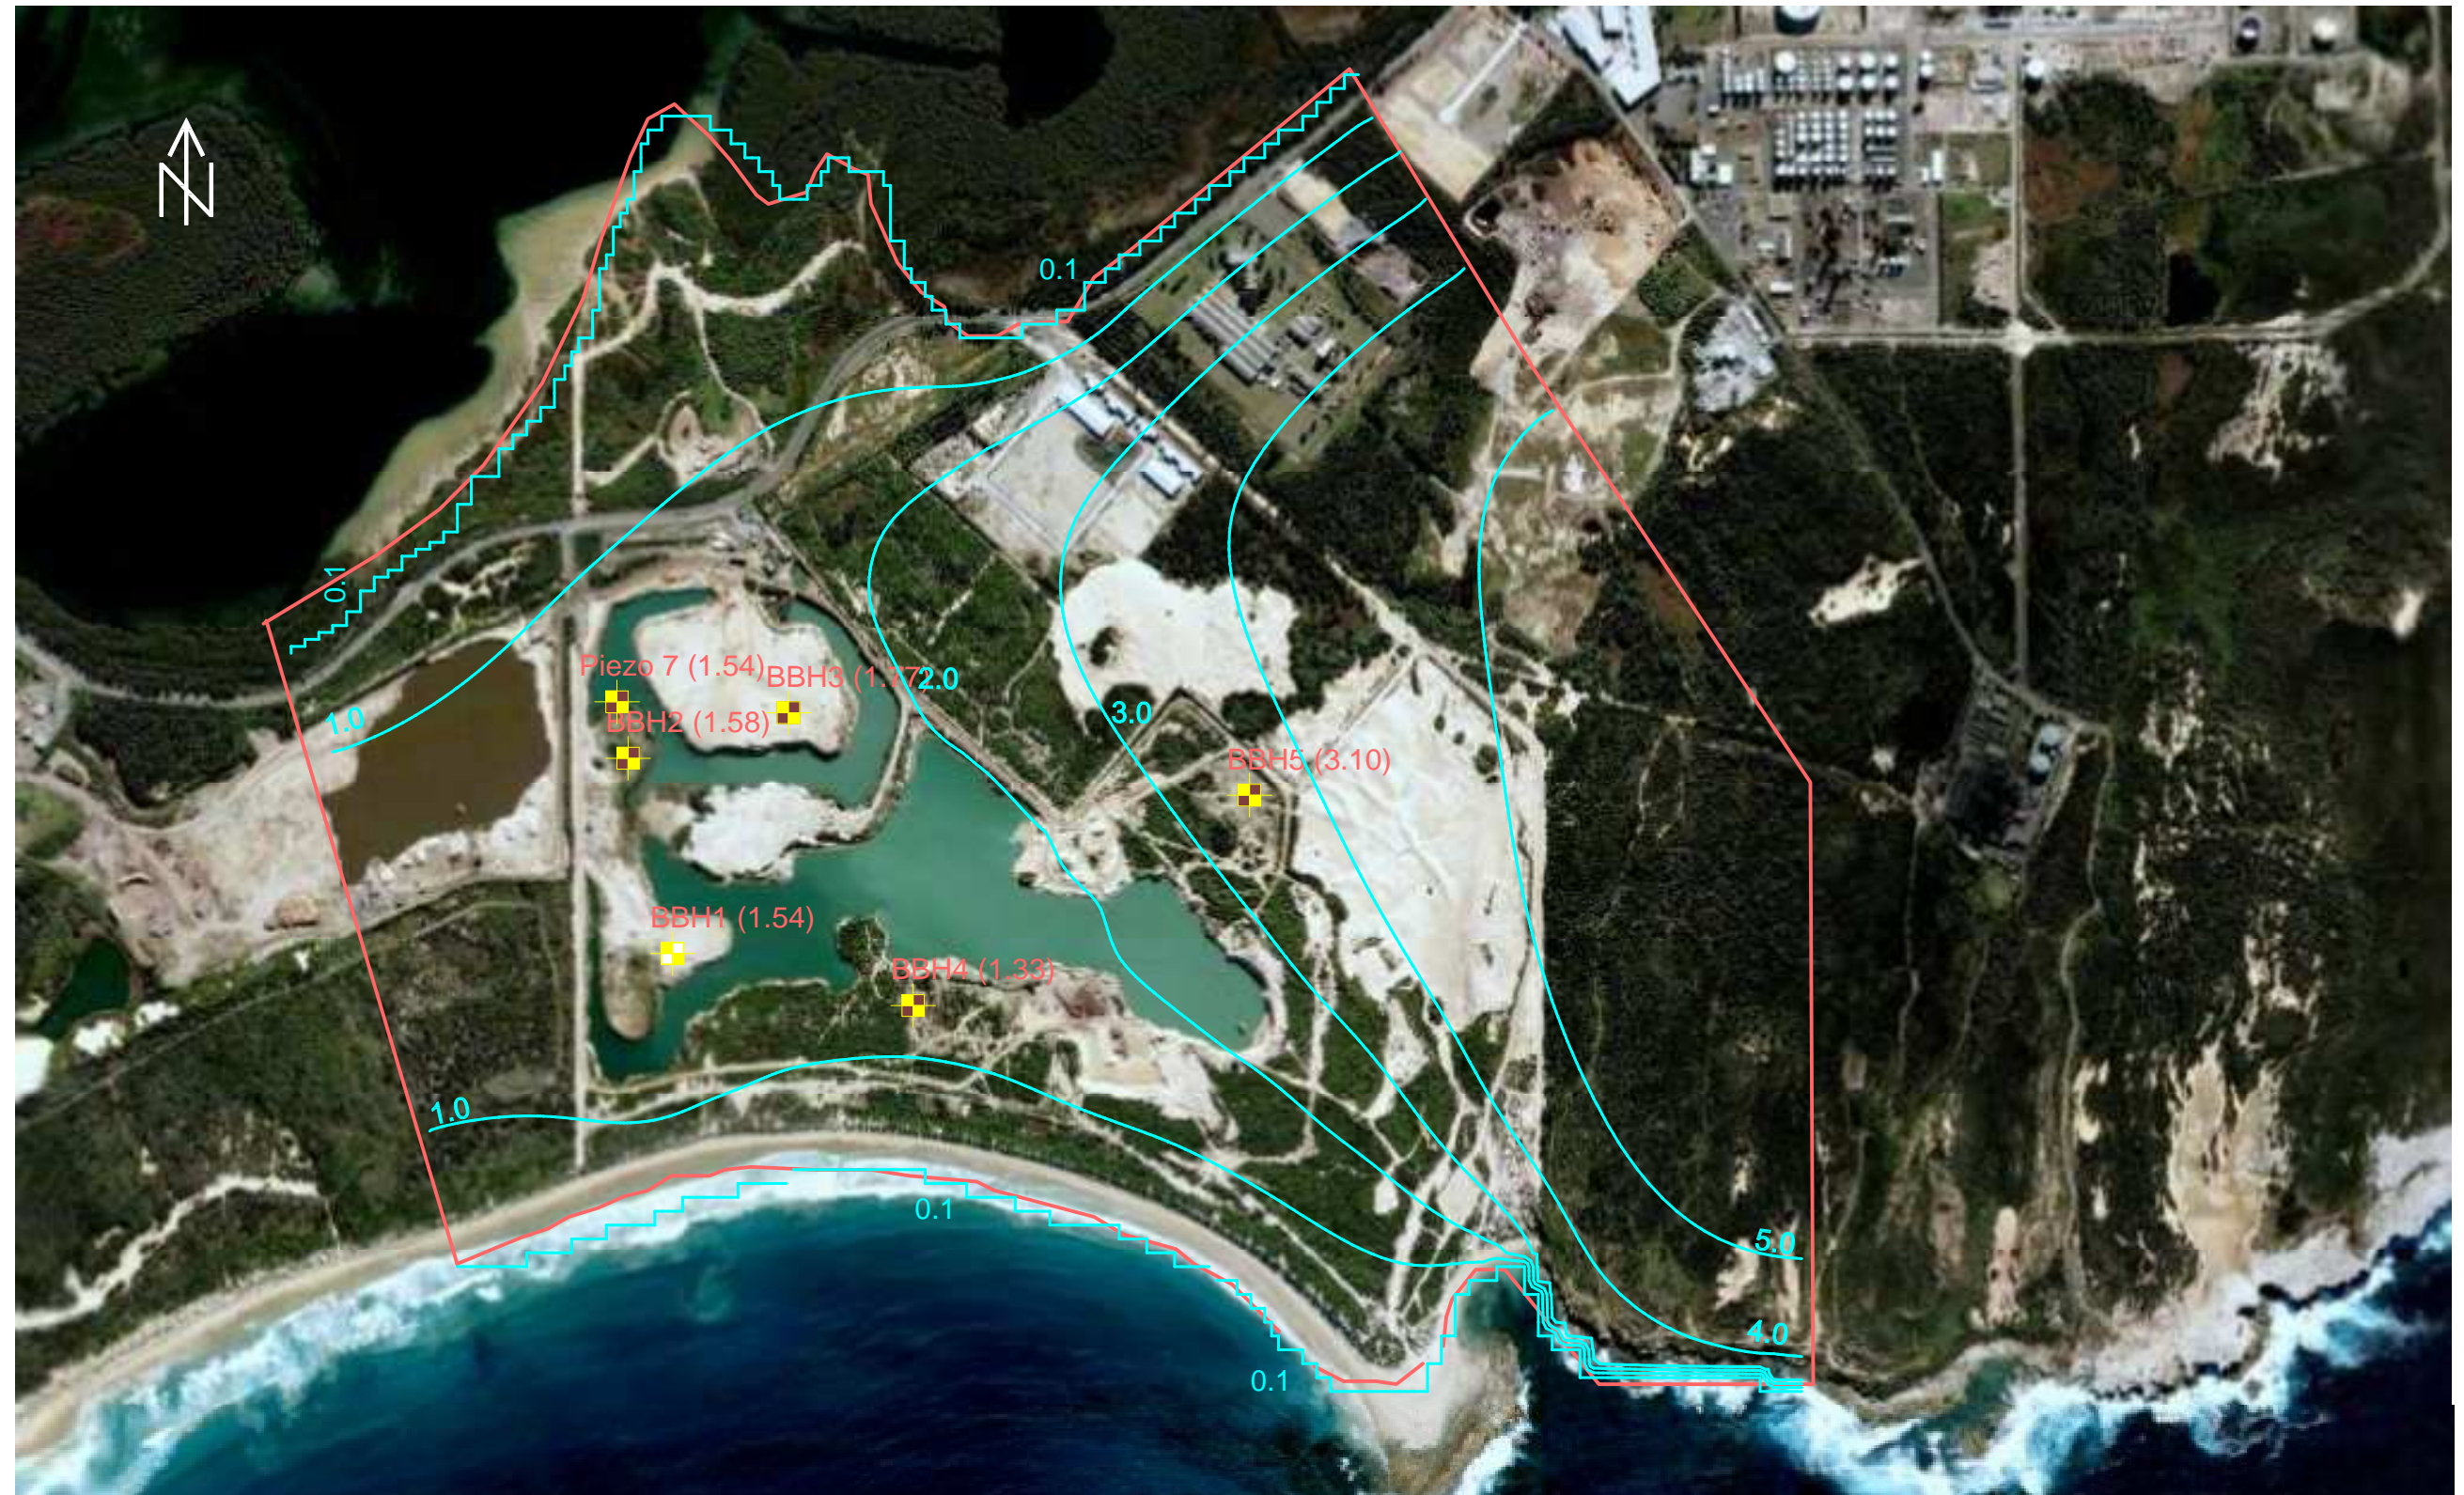
- Active model boundary
- Calculated Groundwater Contour
- 0.5 Calculated Groundwater Level (mAHD)
- BBH3 (1.22) Coffey Piezometer (Calculated Groundwater Level mAHD)

The groundwater flow assessment (Coffey, 2020) was prepared to "*...assess current and likely future groundwater flow directions for the site under the draft masterplan*".¹² The assessment was based on a hydrogeological model initially developed by Coffey in 2007 to allow appraisal of groundwater conditions (in the context of future development) following rehabilitation of the sandmining area. Two model outputs are described in the report (1) groundwater levels and flow between February-August 2003 (used to calibrate the model) and (2) predicted groundwater levels after rehabilitation of the sand mining void. Groundwater contour plots for each of the two scenarios are reproduced in Appendix A.

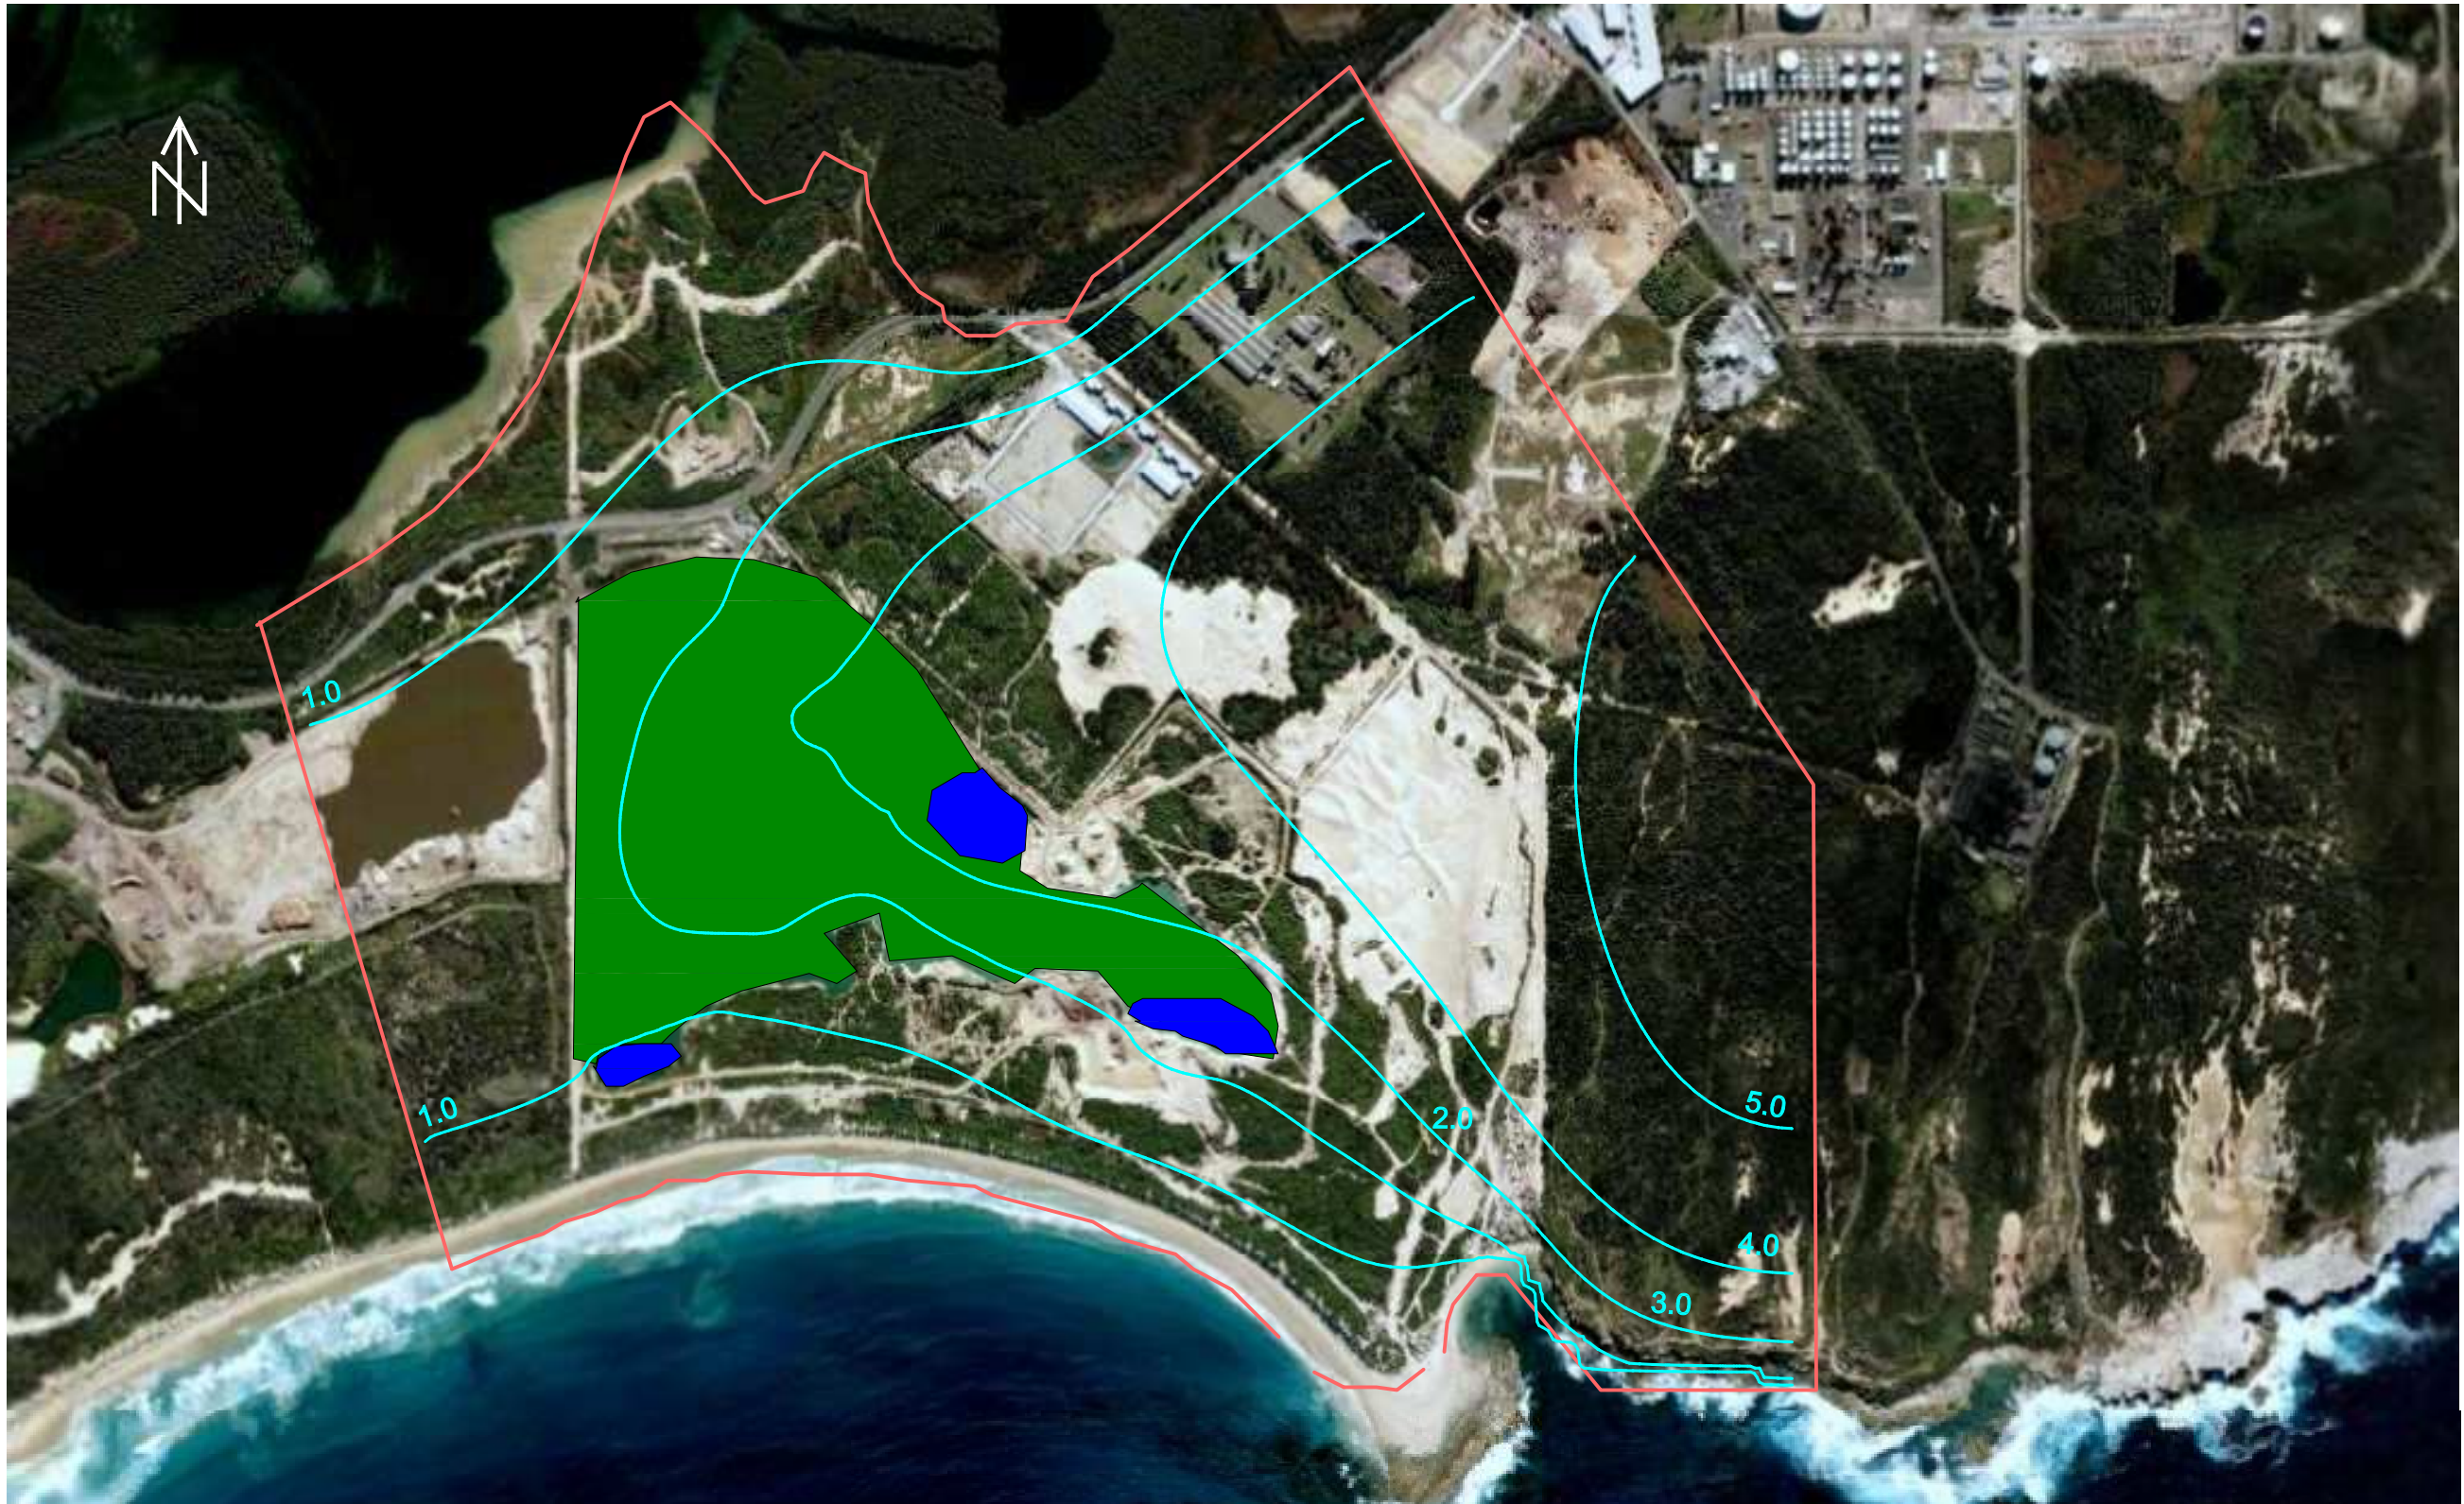
| | | | FIGURE 12 |

- Active model boundary
- Modelled Groundwater Contour
- 0.5 Modelled Groundwater Level (mAHD)
- Remaining Pond Area
- Filled Area

Following rehabilitation (backfilling), the groundwater model generally predicts a return to conditions reported in the PSI, being a groundwater divide across the site with components of flow northwest towards Quibray Bay and south to Bate Bay.

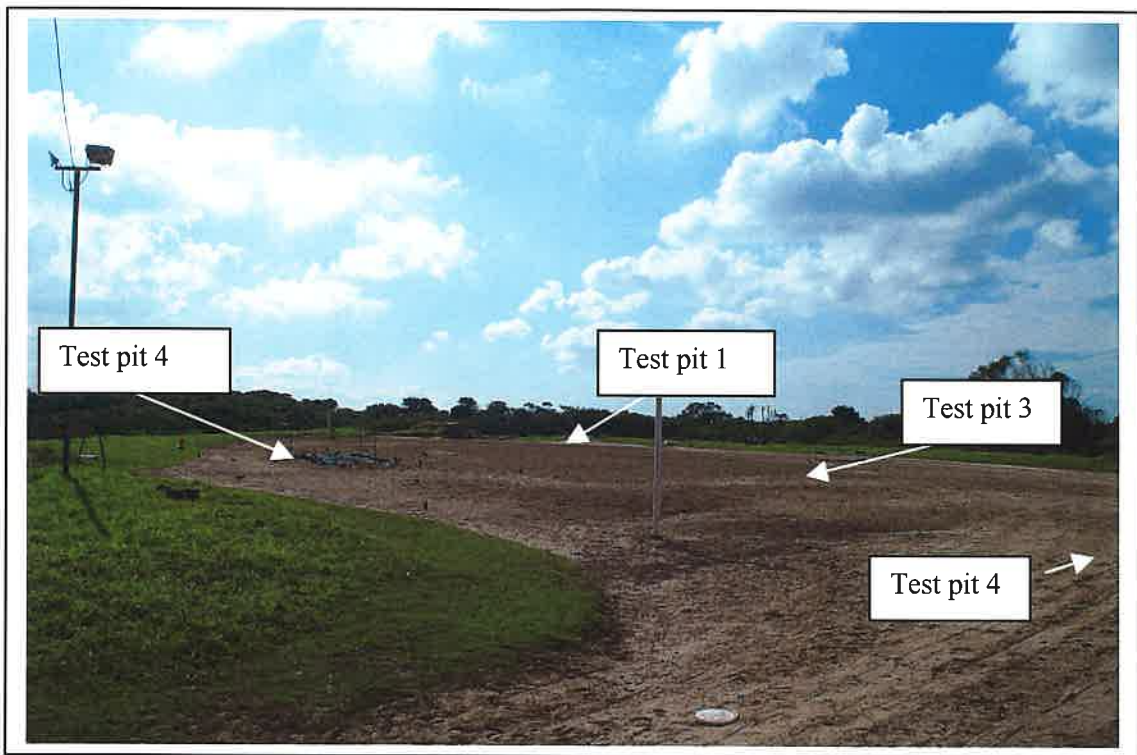
Plate 6 Horse training oval at the equestrian centre on Lot 4 showing approximate position of excavated test pits; view looking north-east.

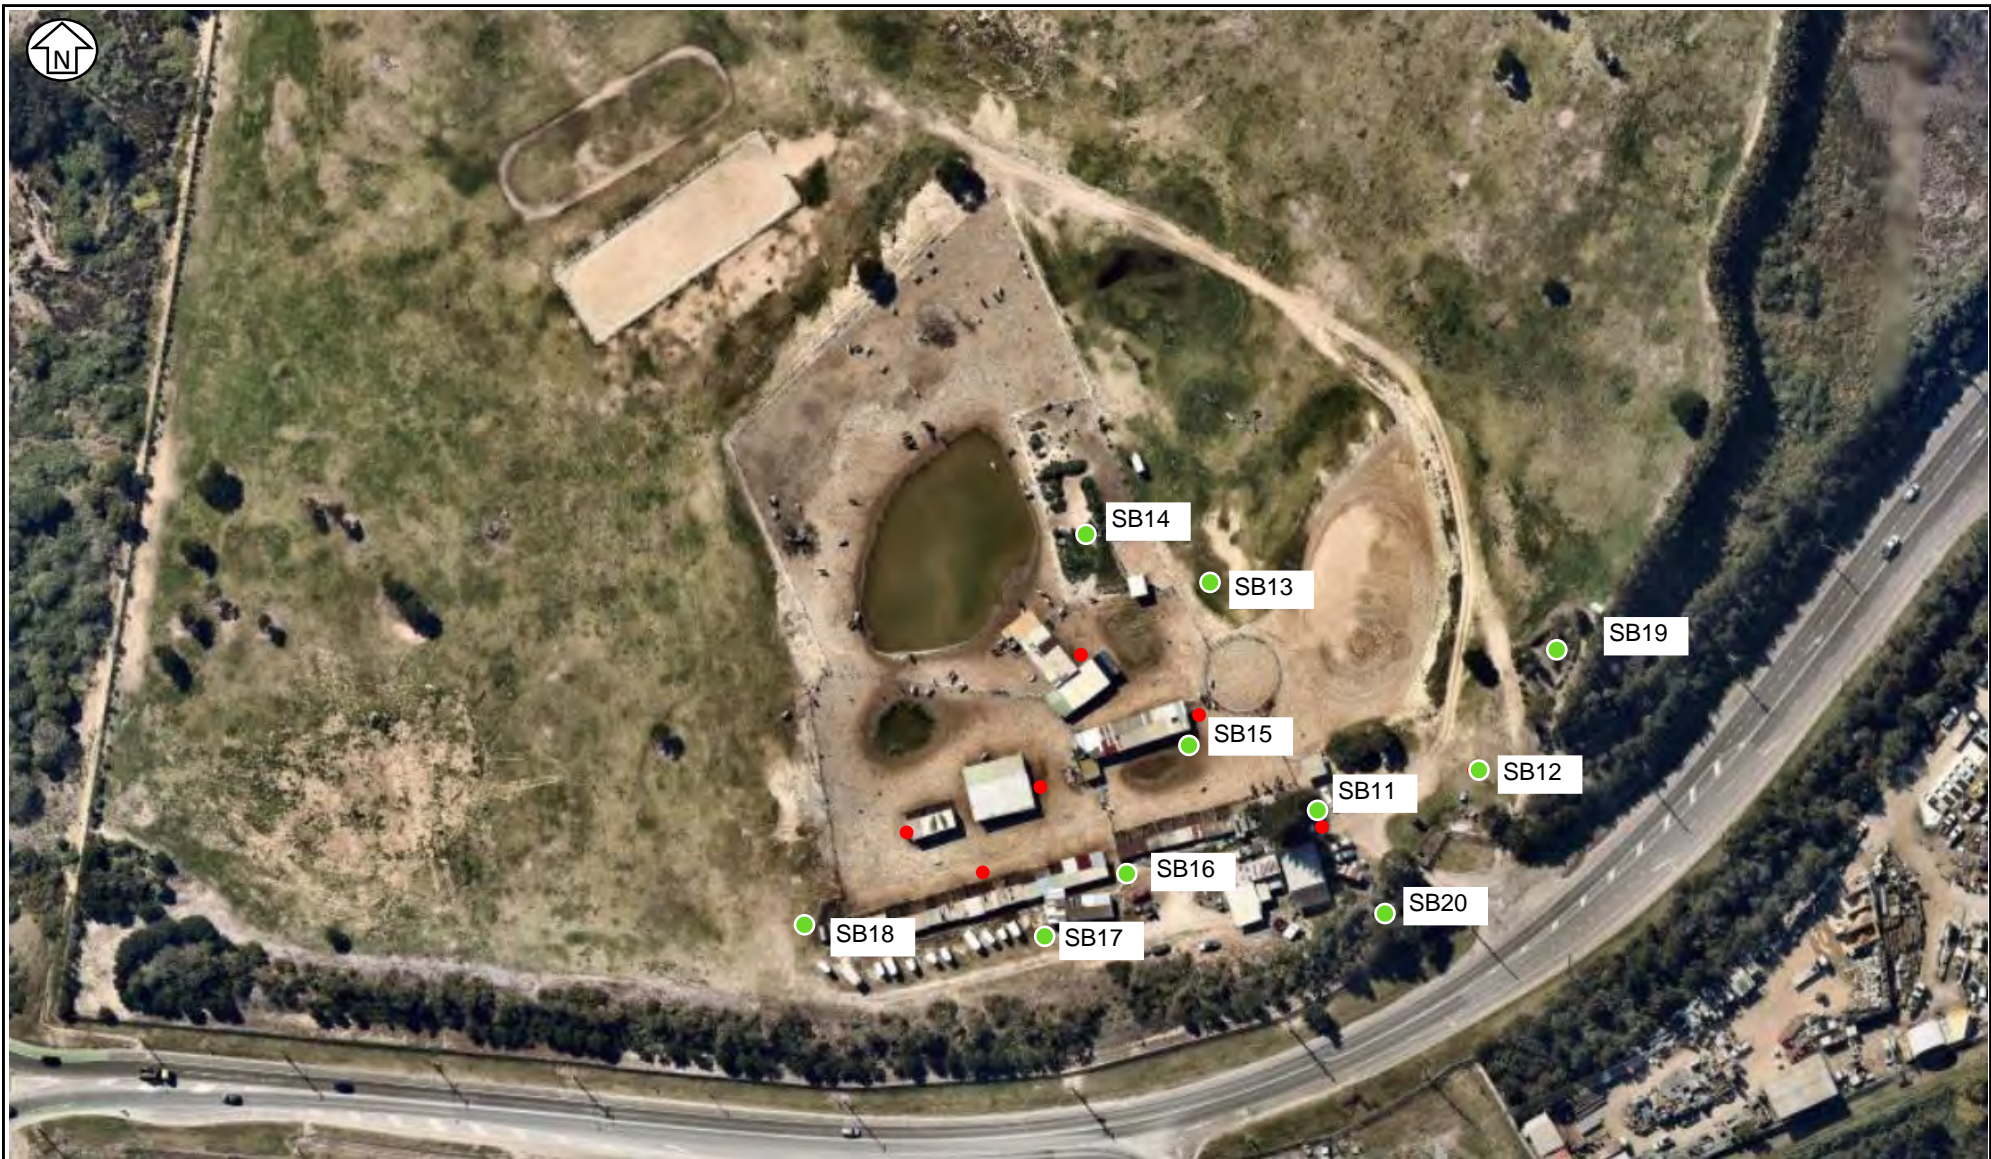
Figure 1: Sample Locations – Lot 2 North

● Proposed soil bore location

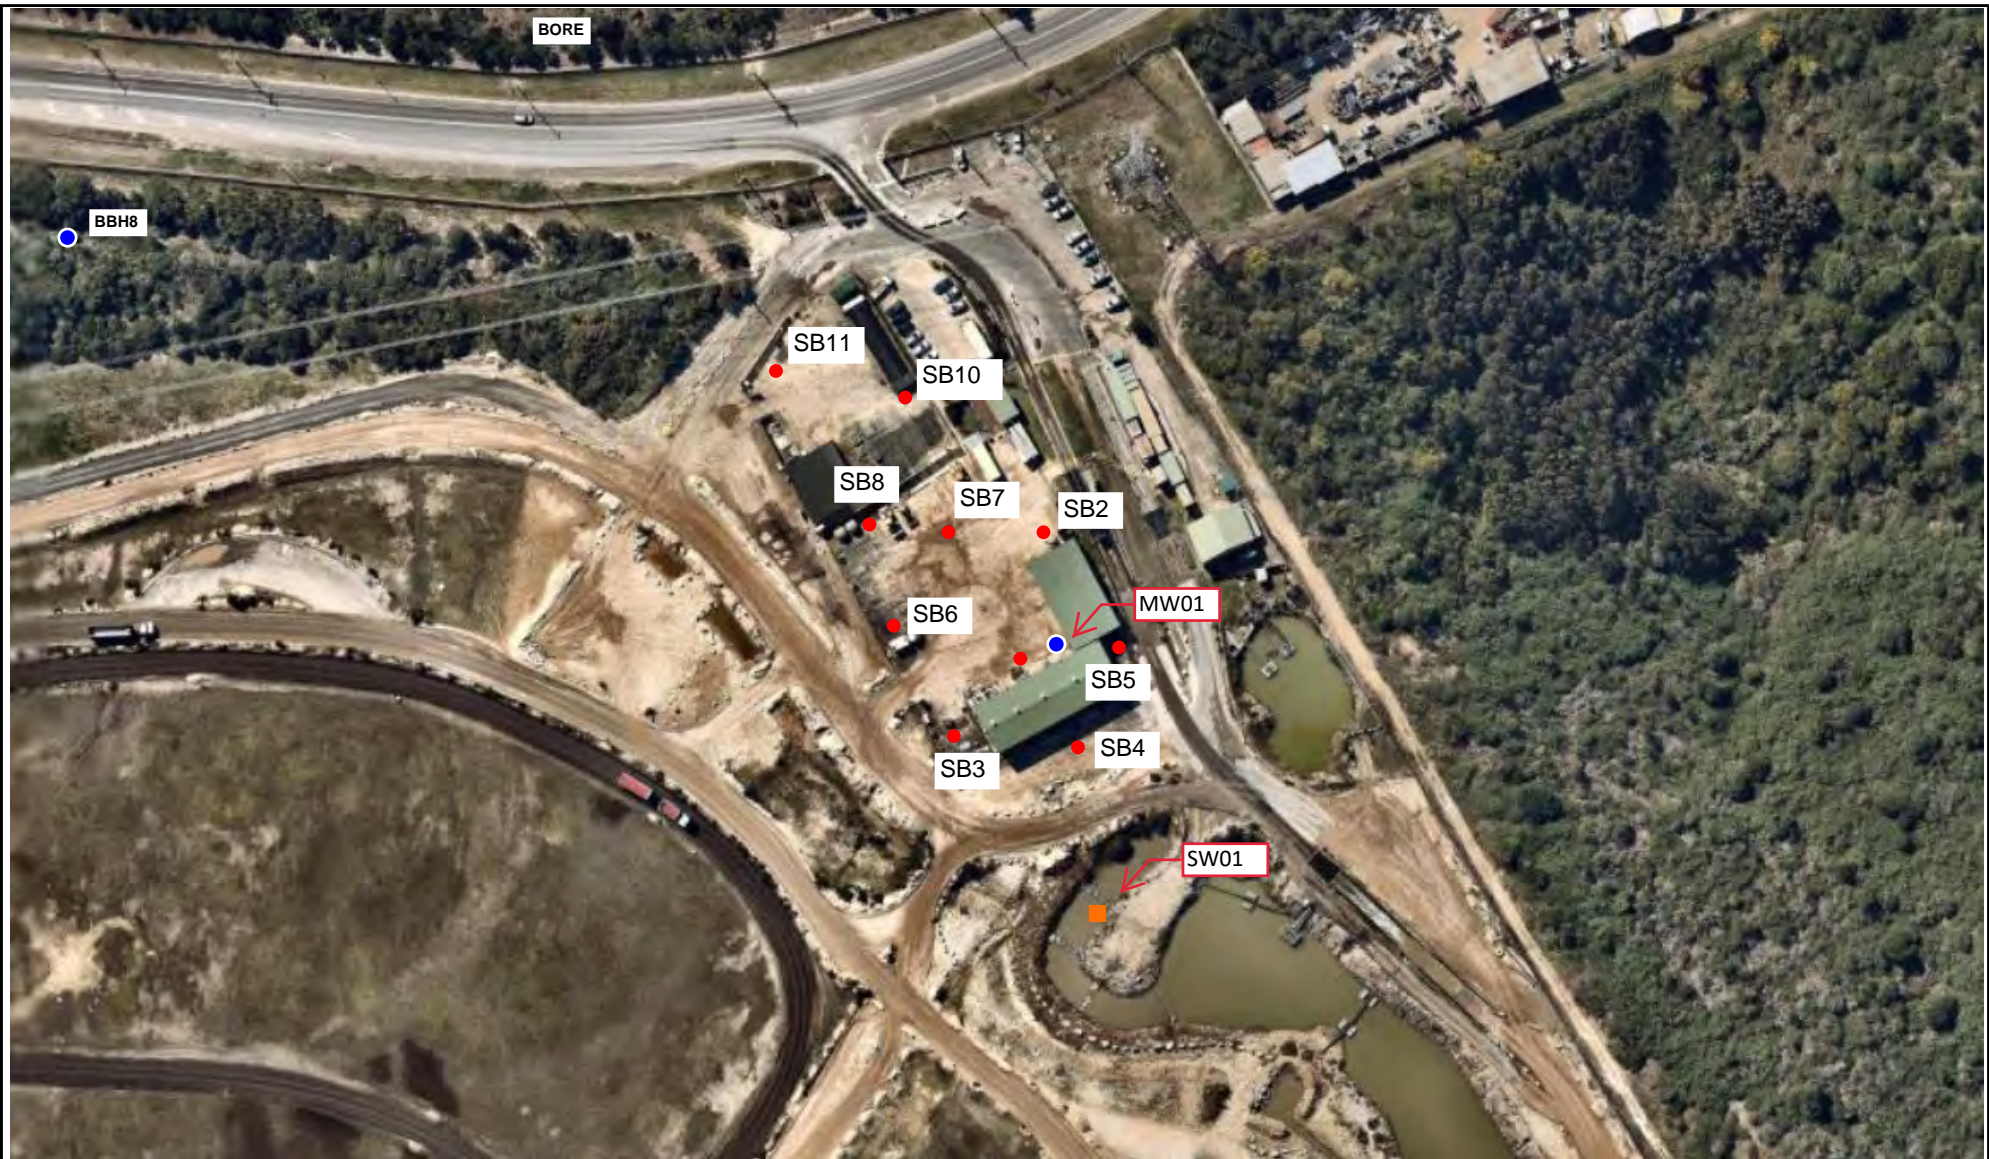
Figure 2: Sample Locations – Lot 2 South

- Soil bore location
- New groundwater monitoring location
- Existing groundwater monitoring well location
- Surface water sampling location

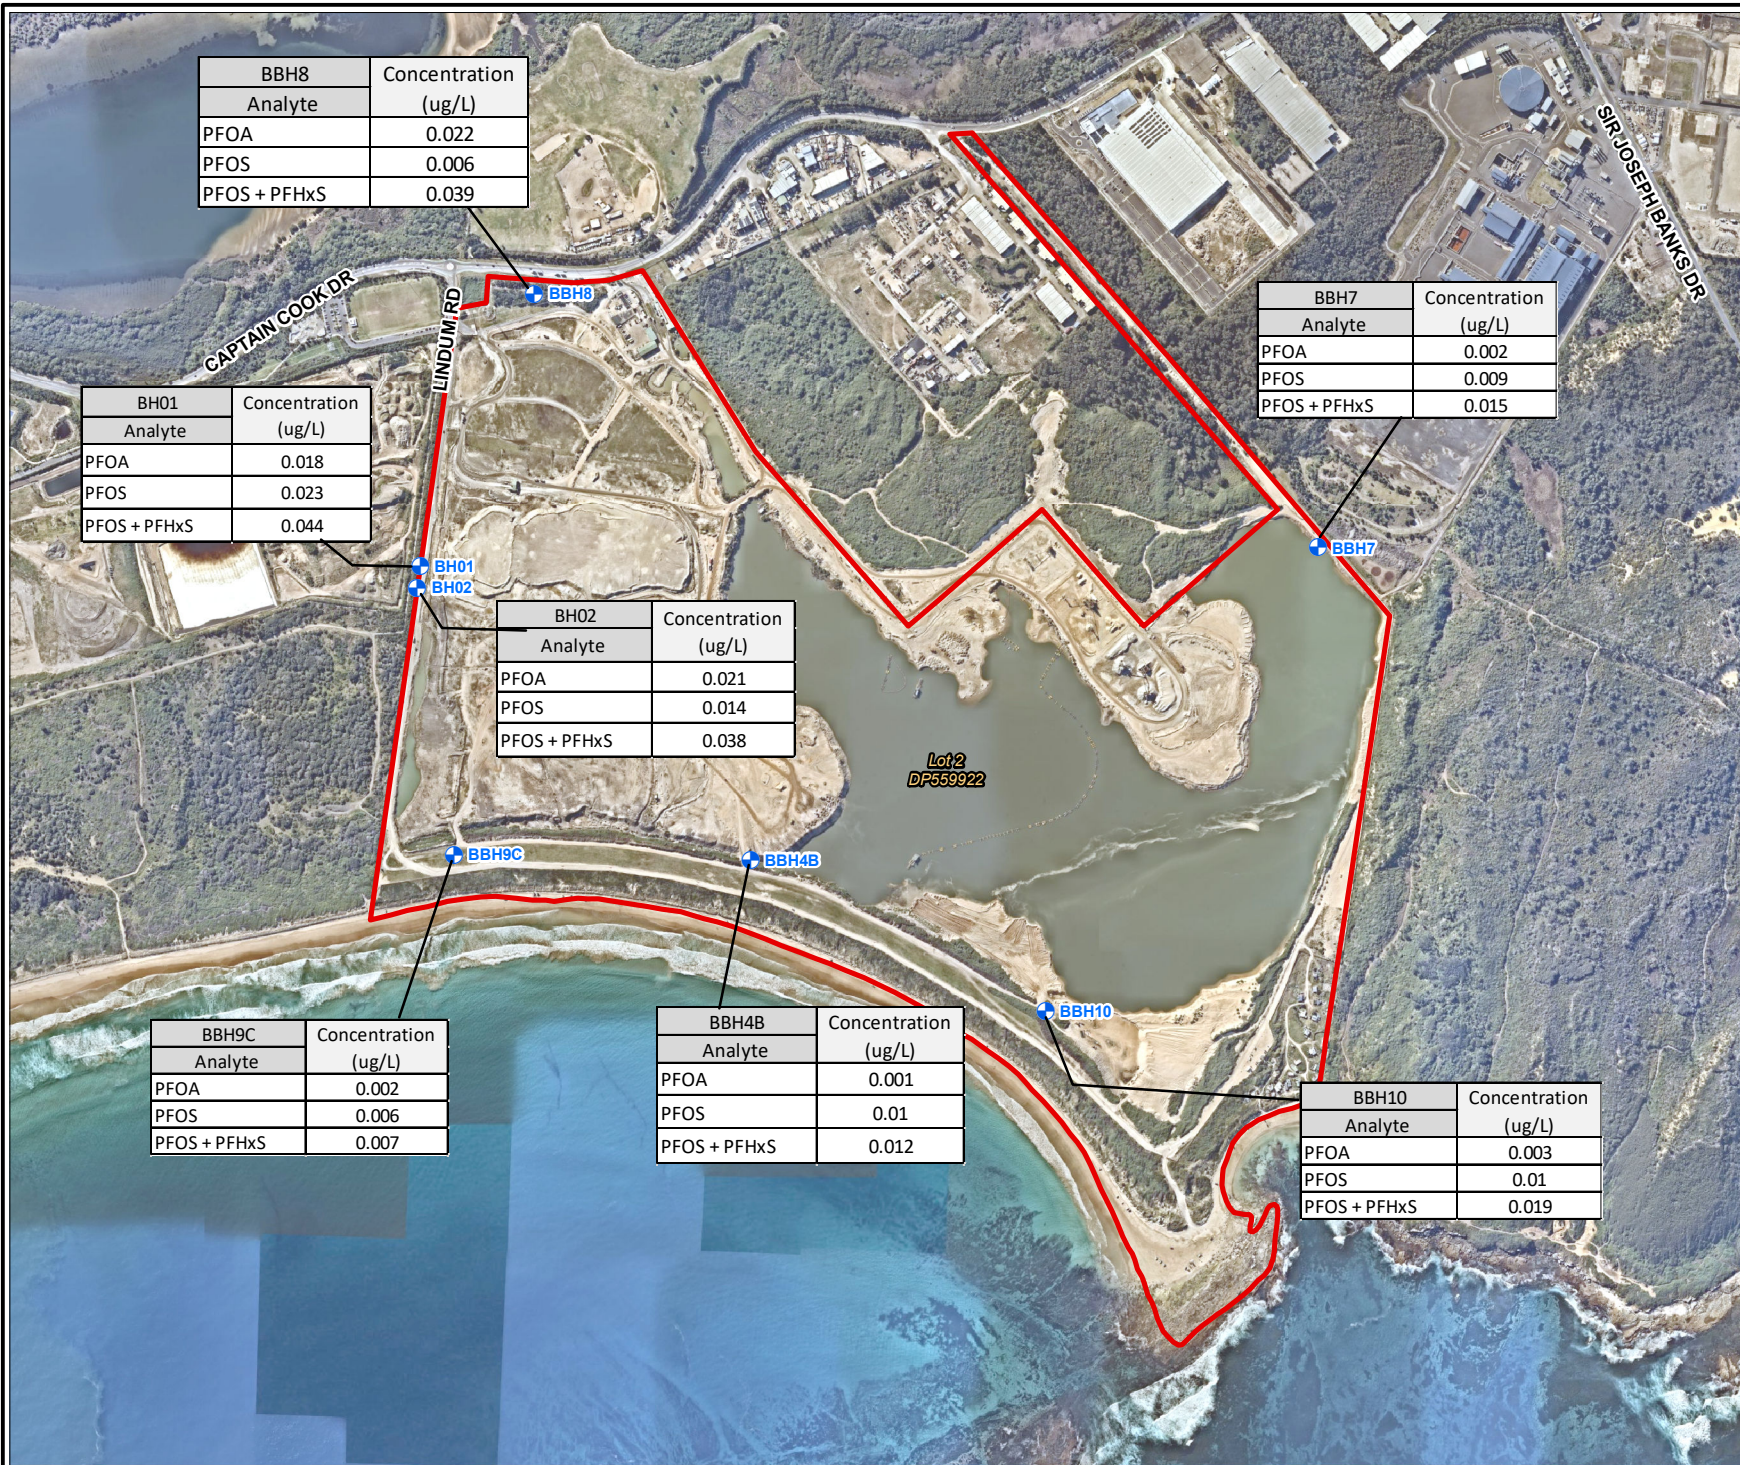
| BBH8 | Concentration |

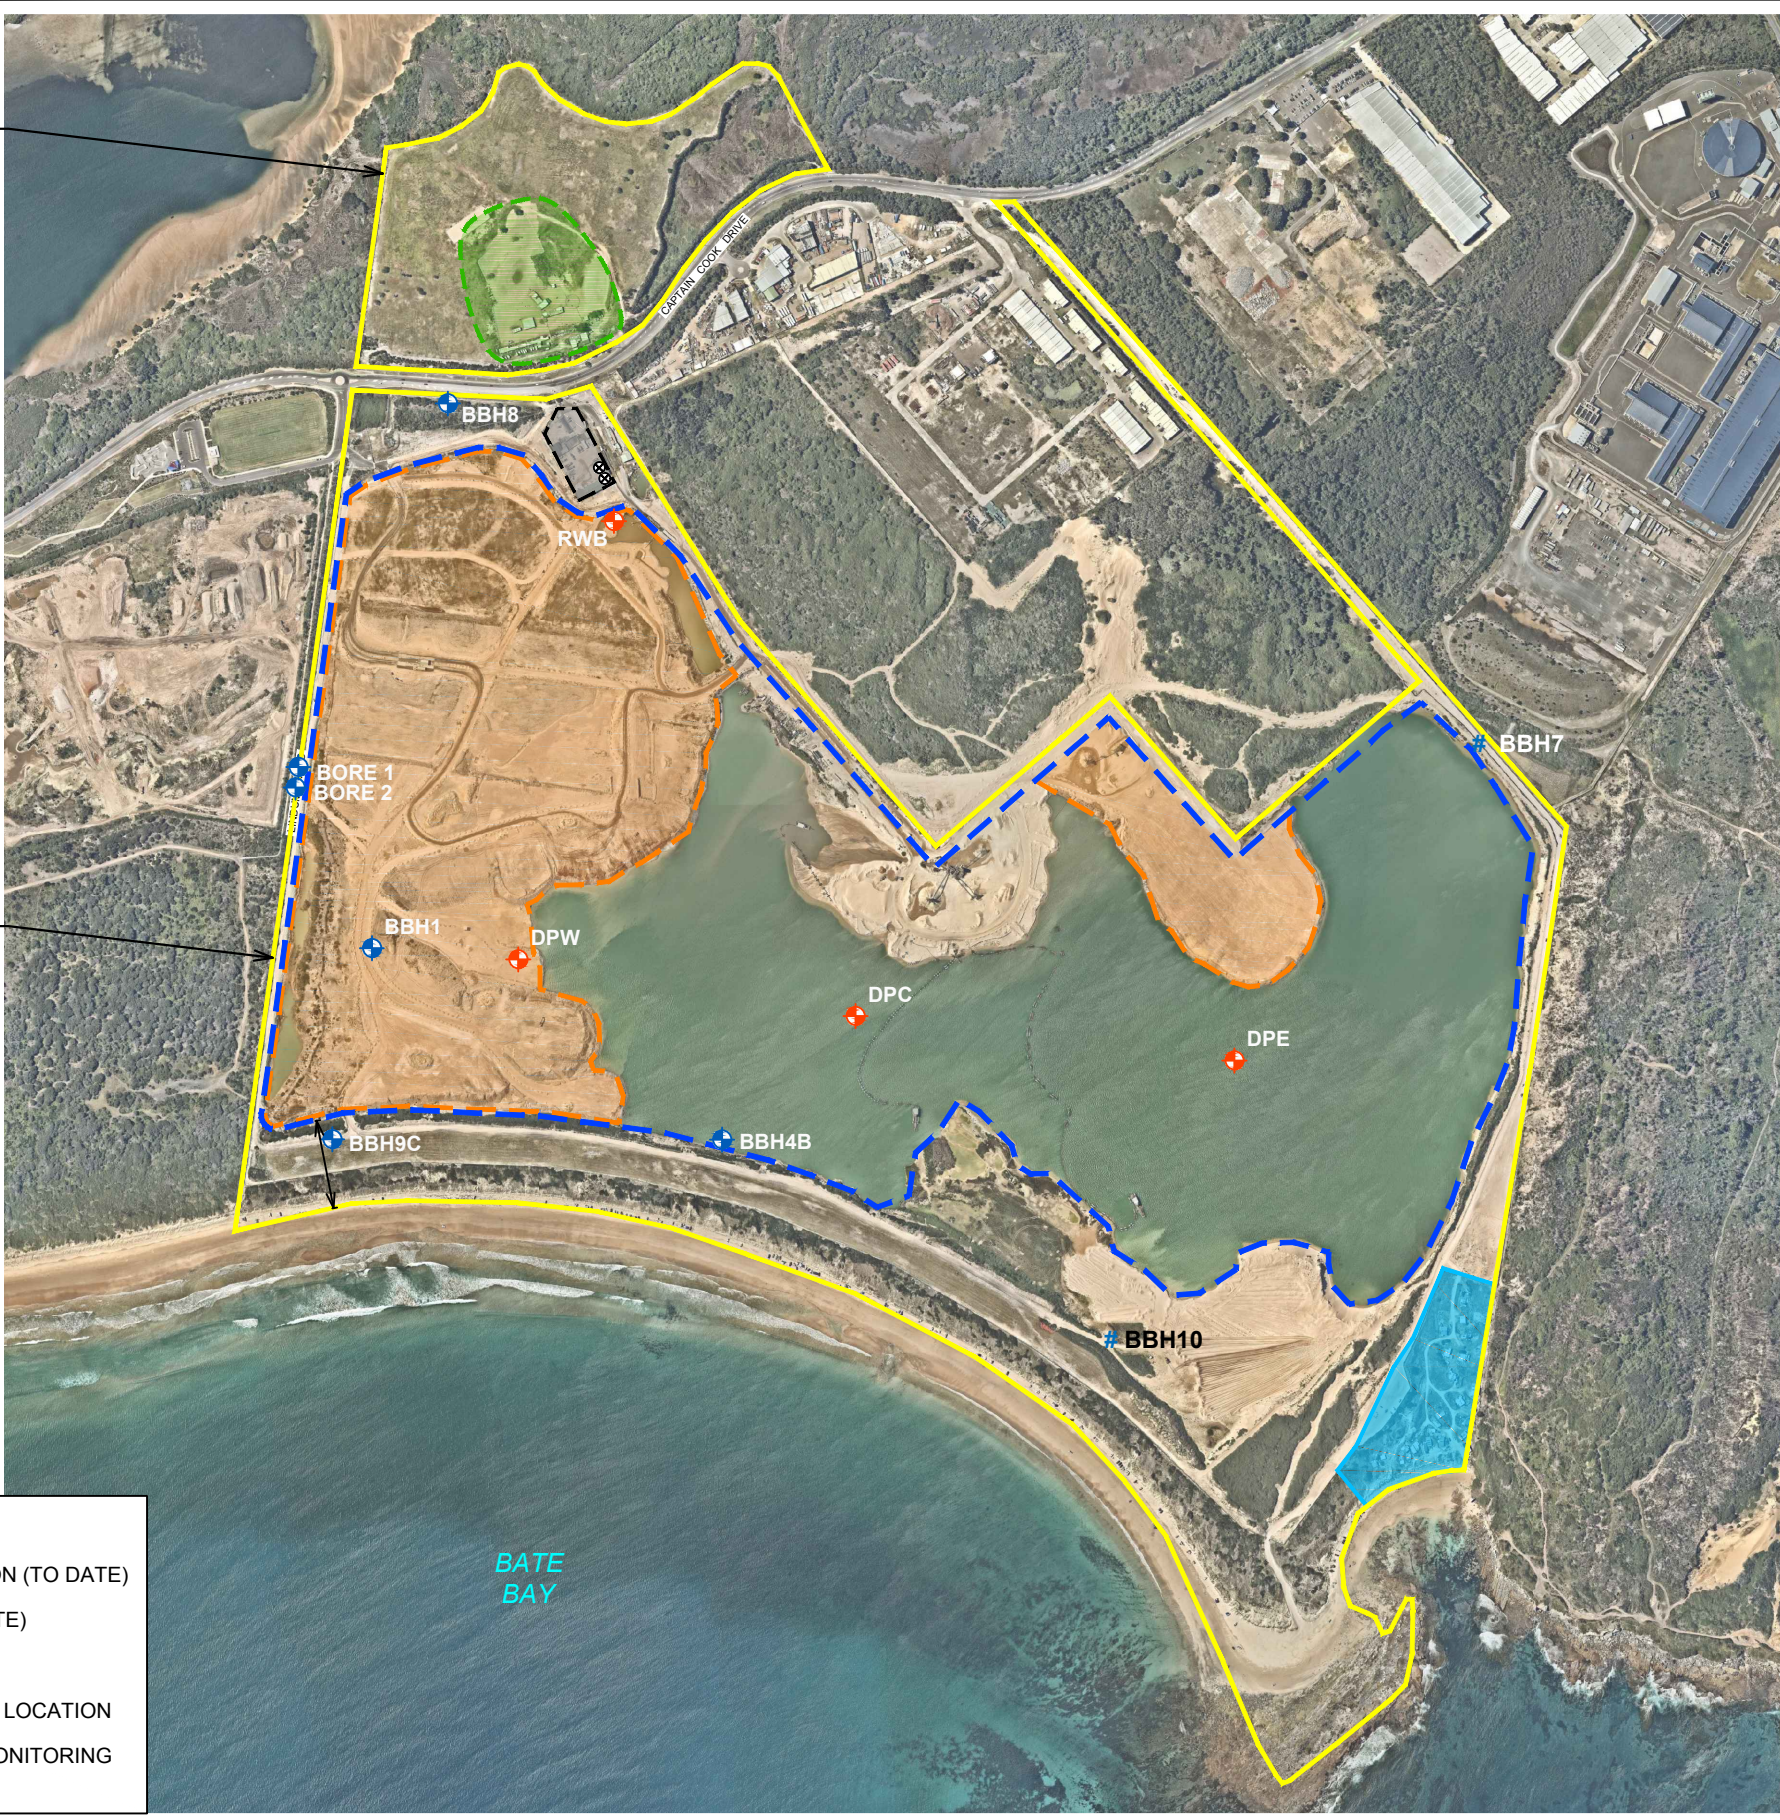
- APPROXIMATE AREA OF SAND EXTRACTION (TO DATE)
- APPROXIMATE AREA OF BACKFILL (TO DATE)
- SITE BOUNDARY
- ◆ PROPOSED WATER QUALITY MONITORING LOCATION
- ◆ APPROXIMATE LOCATION OF CURRENT MONITORING NETWORK PIEZOMETER

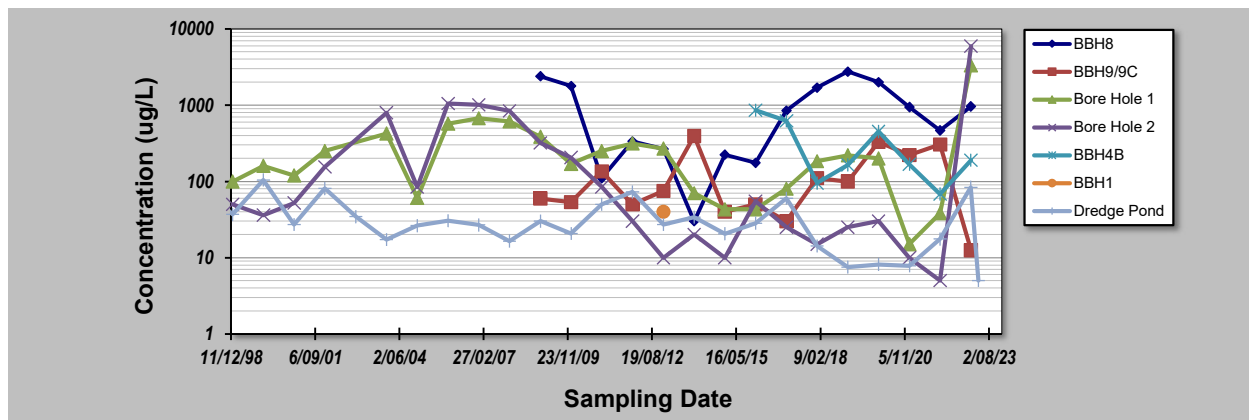
| Sampling Event | Sampling Date | AMMONIA CONCENTRATION (ug/L) | | | | | | |
|---|---|---|---|---|---|---|---|---|
| Confidence Factor: | | 75.2% | 63.3% | 85.5% | 98.8% | 86.2% | | 99.2% |
| Concentration Trend: | | No Trend | No Trend | No Trend | Decreasing | Stable | | Decreasing |

- At least four independent sampling events per well are required for calculating the trend. Methodology is valid for 4 to 40 samples.
- Confidence in Trend = Confidence (in percent) that constituent concentration is increasing (S>0) or decreasing (S<0): >95% = Increasing or Decreasing; ≥ 90% = Probably Increasing or Probably Decreasing; < 90% and S>0 = No Trend; < 90%, S≤0, and COV ≥ 1 = No Trend; < 90% and COV < 1 = Stable.
- Methodology based on "MAROS: A Decision Support System for Optimizing Monitoring Plans", J.J. Aziz, M. Ling, H.S. Rifai, C.J. Newell, and J.R. Gonzales, *Ground Water*, 41(3):355-367, 2003.
