# pre-development tree assessment

## PDTA-01

Revision A, Issued for Information, 30.10.2019

## Cronulla Town Centre Upgrade - Stage 2

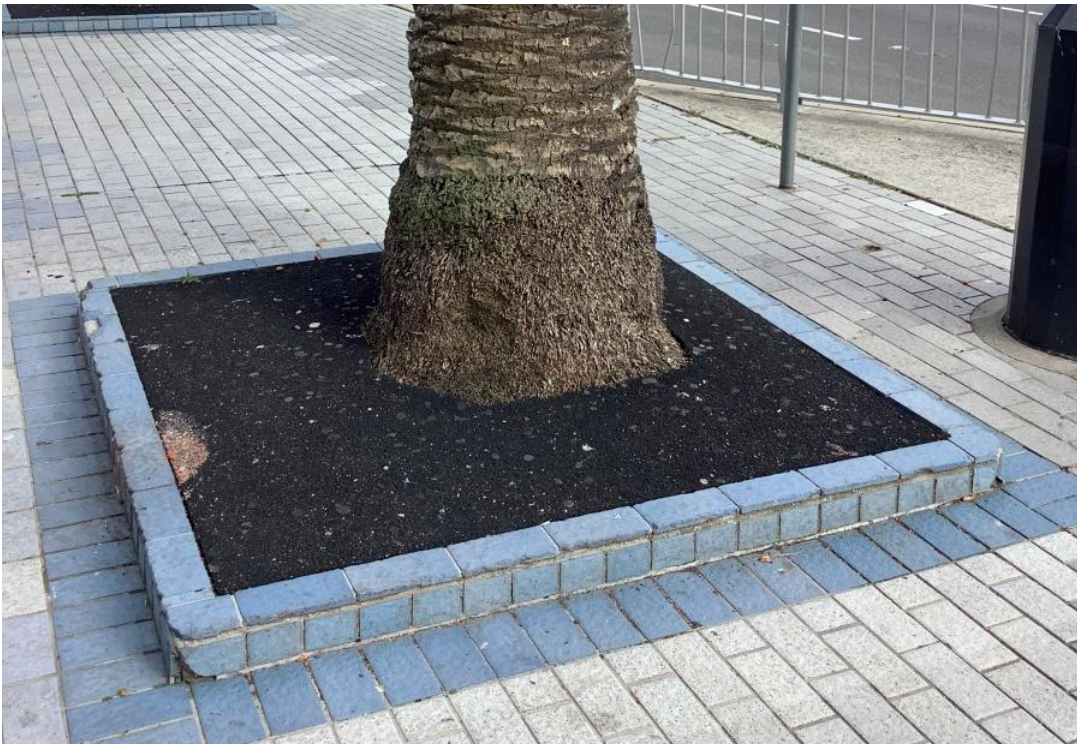
Figure 6 – View of typical palm surround at the northern end of the Mall near Kingsway. (Photo: Arterra 16.10.19)

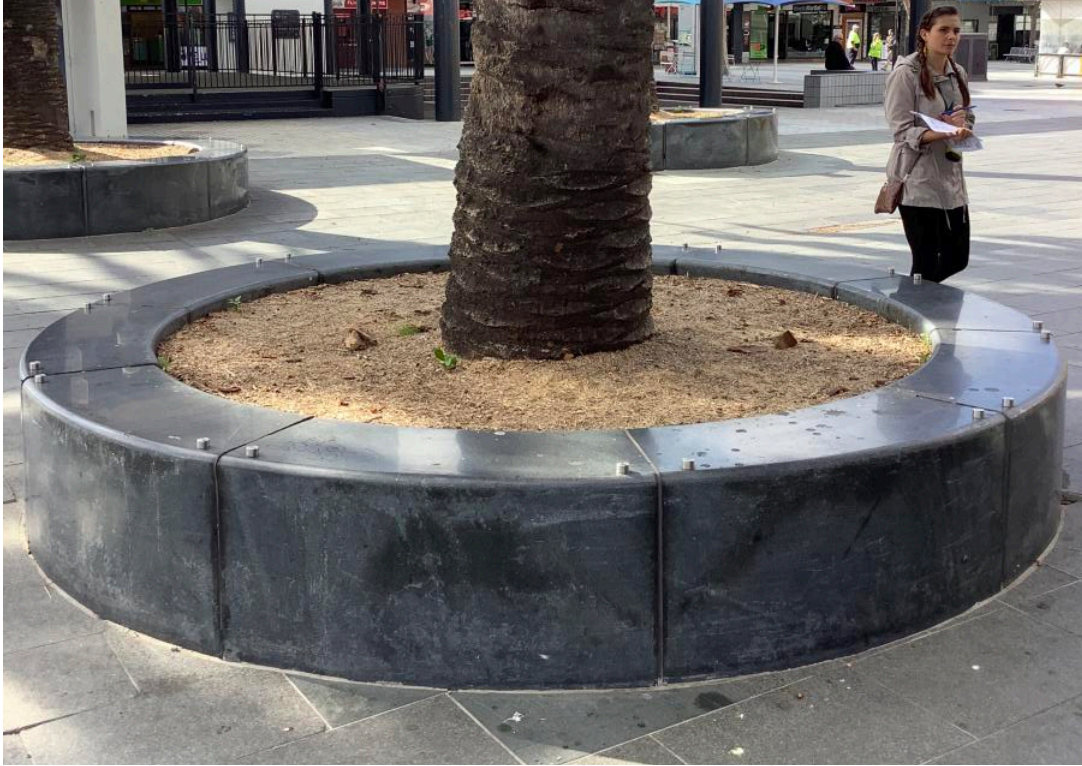
Figure 7 – View of a typical palm within a raised concrete seatwall surround at the northern end of the Mall. (Photo: Arterra 16.10.19)

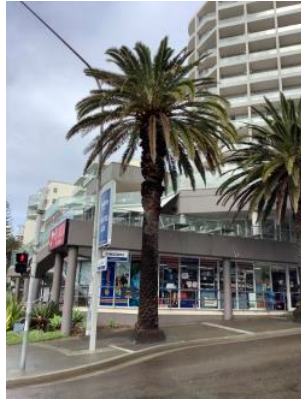
ID # 01  
Species: *Phoenix canariensis*  
Common: Canary Island Date Palm  
Height (m): 6.8  
DBH (m): 0.73 DGL (m): 1.19  
Current Form: Good  
Current Vigour: Fair  
Age Class: Mature  
SULE: Long (>40 years)

Retention Value: High

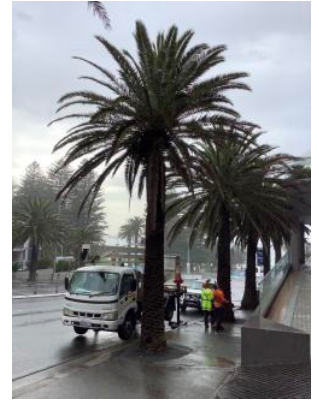
ID # 05  
Species: *Phoenix canariensis*  
Common: Canary Island Date Palm  
Height (m): 5.2  
DBH (m): 0.58 DGL (m): 0.80  
Current Form: Good  
Current Vigour: Fair  
Age Class: Mature  
SULE: Long (>40 years)

Retention Value: High

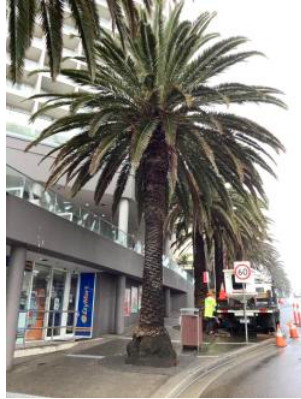
ID # 02  
Species: *Phoenix canariensis*  
Common: Canary Island Date Palm  
Height (m): 6.6  
DBH (m): 0.67 DGL (m): 1.30  
Current Form: Good  
Current Vigour: Fair  
Age Class: Mature  
SULE: Long (>40 years)

Retention Value: High

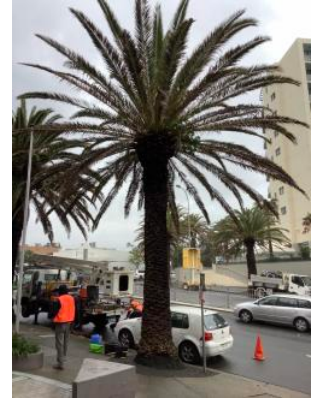
ID # 06  
Species: *Phoenix canariensis*  
Common: Canary Island Date Palm  
Height (m): 5.8  
DBH (m): 0.79 DGL (m): 1.20  
Current Form: Good  
Current Vigour: Fair  
Age Class: Mature  
SULE: Long (>40 years)

Retention Value: High

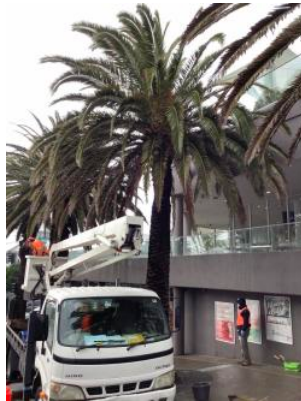
ID # 03  
Species: *Phoenix canariensis*  
Common: Canary Island Date Palm  
Height (m): 5.4  
DBH (m): 0.74 DGL (m): 1.41  
Current Form: Good  
Current Vigour: Fair  
Age Class: Mature  
SULE: Long (>40 years)

Retention Value: High

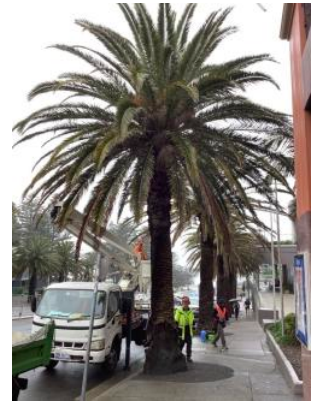
ID # 07  
Species: *Phoenix canariensis*  
Common: Canary Island Date Palm  
Height (m): 5.8  
DBH (m): 0.66 DGL (m): 1.23  
Current Form: Good  
Current Vigour: Fair  
Age Class: Mature  
SULE: Long (>40 years)

Retention Value: High

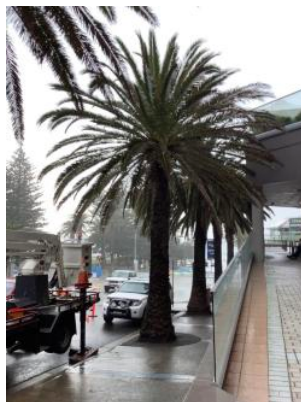
ID # 04  
Species: *Phoenix canariensis*  
Common: Canary Island Date Palm  
Height (m): 5.4  
DBH (m): 0.72 DGL (m): 1.18  
Current Form: Good  
Current Vigour: Fair  
Age Class: Mature  
SULE: Long (>40 years)

Retention Value: High

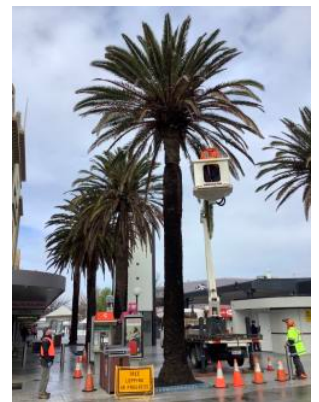
ID # 08  
Species: *Phoenix canariensis*  
Common: Canary Island Date Palm  
Height (m): 8.6  
DBH (m): 0.67 DGL (m): 1.10  
Current Form: Good  
Current Vigour: Fair  
Age Class: Mature  
SULE: Long (>40 years)

Retention Value: High

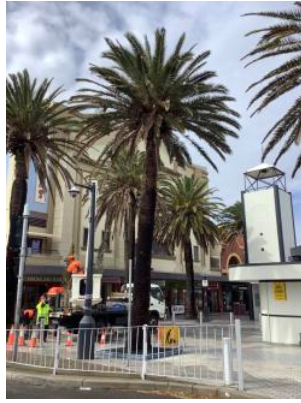
ID # 09  
Species: *Phoenix canariensis*  
Common: Canary Island Date Palm  
Height (m): 7.2  
DBH (m): 0.59 DGL (m): 0.83  
Current Form: Good  
Current Vigour: Fair  
Age Class: Mature  
SULE: Long (>40 years)

Retention Value: High

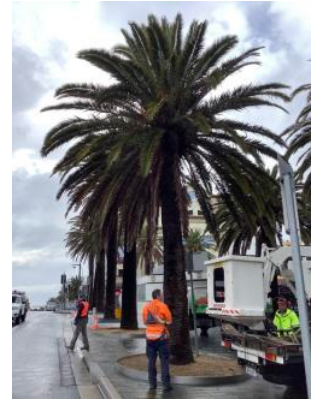
ID # 13  
Species: *Phoenix canariensis*  
Common: Canary Island Date Palm  
Height (m): 6.6  
DBH (m): 0.65 DGL (m): 0.75  
Current Form: Good  
Current Vigour: Fair  
Age Class: Mature  
SULE: Long (>40 years)

Retention Value: High

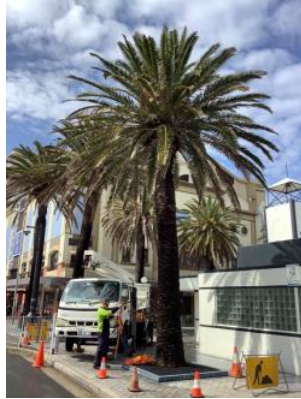
ID # 10  
Species: *Phoenix canariensis*  
Common: Canary Island Date Palm  
Height (m): 6.6  
DBH (m): 0.64 DGL (m): 0.92  
Current Form: Good  
Current Vigour: Fair  
Age Class: Mature  
SULE: Long (>40 years)

Retention Value: High

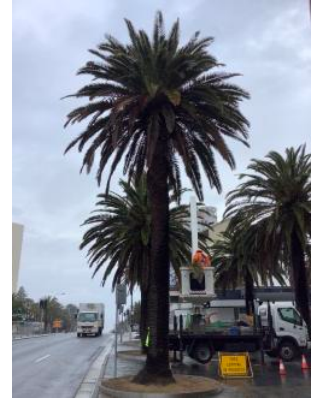
ID # 14  
Species: *Phoenix canariensis*  
Common: Canary Island Date Palm  
Height (m): 6.8  
DBH (m): 0.57 DGL (m): 1.07  
Current Form: Good  
Current Vigour: Fair  
Age Class: Mature  
SULE: Long (>40 years)

Retention Value: High

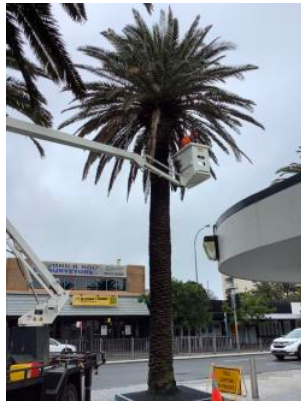
ID # 11  
Species: *Phoenix canariensis*  
Common: Canary Island Date Palm  
Height (m): 8.2  
DBH (m): 0.65 DGL (m): 0.80  
Current Form: Good  
Current Vigour: Fair  
Age Class: Mature  
SULE: Long (>40 years)

Retention Value: High

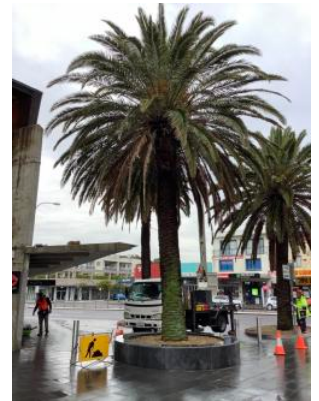
ID # 15  
Species: *Phoenix canariensis*  
Common: Canary Island Date Palm  
Height (m): 6.0  
DBH (m): 0.64 DGL (m): 0.79  
Current Form: Good  
Current Vigour: Fair  
Age Class: Mature  
SULE: Long (>40 years)

Retention Value: High

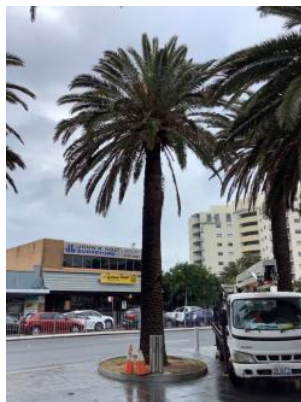
ID # 12  
Species: *Phoenix canariensis*  
Common: Canary Island Date Palm  
Height (m): 7.0  
DBH (m): 0.70 DGL (m): 0.93  
Current Form: Good  
Current Vigour: Fair  
Age Class: Mature  
SULE: Long (>40 years)

Retention Value: High

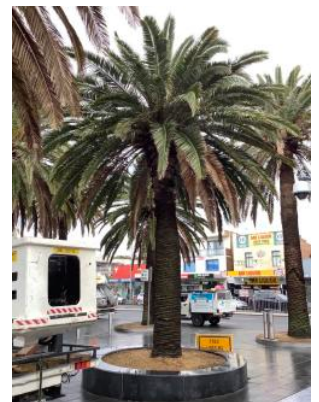
ID # 16  
Species: *Phoenix canariensis*  
Common: Canary Island Date Palm  
Height (m): 4.8  
DBH (m): 0.62 DGL (m): 0.71  
Current Form: Good  
Current Vigour: Fair  
Age Class: Mature  
SULE: Long (>40 years)

Retention Value: High

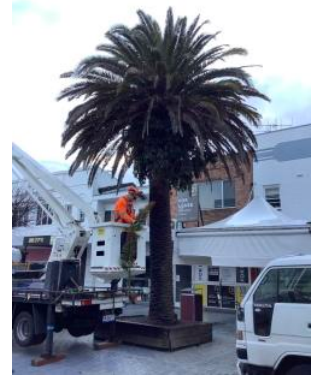
ID # 21  
Species: *Phoenix canariensis*  
Common: Canary Island Date Palm  
Height (m): 5.8  
DBH (m): 0.65 DGL (m): 0.81  
Current Form: Good  
Current Vigour: Fair  
Age Class: Mature  
SULE: Long (>40 years)

Retention Value: **High**

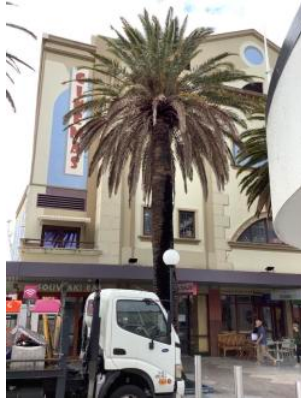
ID # 18  
Species: *Phoenix canariensis*  
Common: Canary Island Date Palm  
Height (m): 7.8  
DBH (m): 0.68 DGL (m): 1.06  
Current Form: Good  
Current Vigour: Fair  
Age Class: Mature  
SULE: Long (>40 years)

Retention Value: **High**

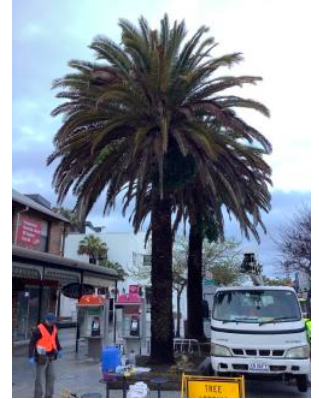
ID # 22  
Species: *Phoenix canariensis*  
Common: Canary Island Date Palm  
Height (m): 6.2  
DBH (m): 0.58 DGL (m): 0.75  
Current Form: Good  
Current Vigour: Fair  
Age Class: Mature  
SULE: Long (>40 years)

Retention Value: **High**

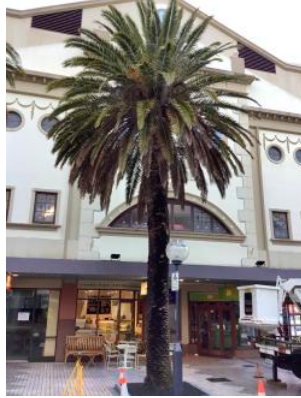
ID # 19  
Species: *Phoenix canariensis*  
Common: Canary Island Date Palm  
Height (m): 6.6  
DBH (m): 0.65 DGL (m): 0.89  
Current Form: Good  
Current Vigour: Fair  
Age Class: Mature  
SULE: Long (>40 years)

Retention Value: **High**

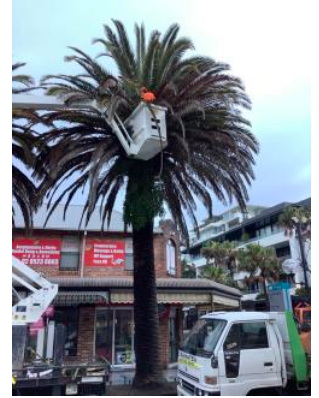
ID # 23  
Species: *Phoenix canariensis*  
Common: Canary Island Date Palm  
Height (m): 6.6  
DBH (m): 0.66 DGL (m): 0.97  
Current Form: Good  
Current Vigour: Fair  
Age Class: Mature  
SULE: Long (>40 years)

Retention Value: **High**

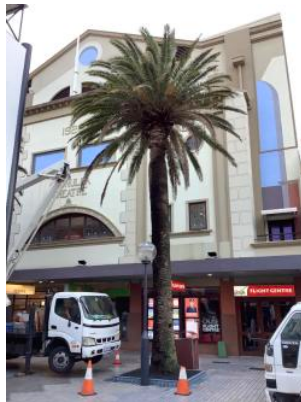
ID # 20  
Species: *Phoenix canariensis*  
Common: Canary Island Date Palm  
Height (m): 7.7  
DBH (m): 0.62 DGL (m): 0.96  
Current Form: Good  
Current Vigour: Fair  
Age Class: Mature  
SULE: Long (>40 years)

Retention Value: **High**

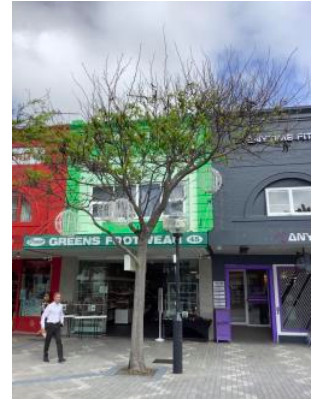
ID # 29  
Species: *Gleditsia triacanthos 'Shademaster'*  
Common: Honey Locust  
Height (m): 6.8  
DBH (m): 0.25 DGL (m): 0.38  
Current Form: Good  
Current Vigour: Fair  
Age Class: Mature  
SULE: Medium (15-40 years)

Retention Value: Low

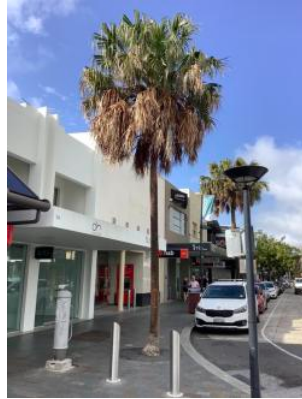
ID # 26  
Species: *Livistona australis*  
Common: Cabbage Palm  
Height (m): 5.8  
DBH (m): 0.22 DGL (m): 0.46  
Current Form: Good  
Current Vigour: Fair  
Age Class: Mature  
SULE: Long (>40 years)

Retention Value: High

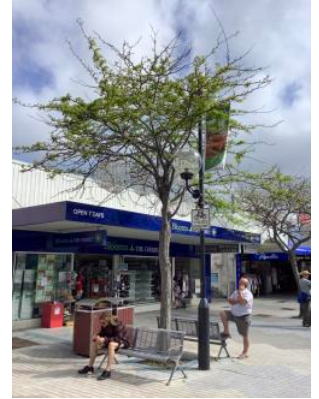
ID # 30  
Species: *Gleditsia triacanthos 'Shademaster'*  
Common: Honey Locust  
Height (m): 5.8  
DBH (m): 0.23 DGL (m): 0.31  
Current Form: Good  
Current Vigour: Good  
Age Class: Mature  
SULE: Medium (15-40 years)

Retention Value: Low

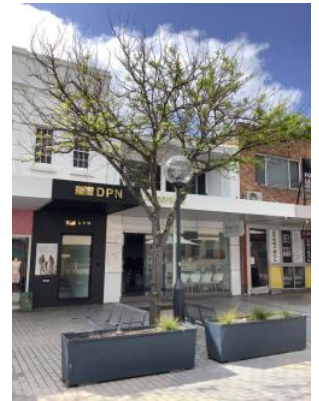
ID # 31  
Species: *Gleditsia triacanthos 'Shademaster'*  
Common: Honey Locust  
Height (m): 5.2  
DBH (m): 0.22 DGL (m): 0.30  
Current Form: Good  
Current Vigour: Fair  
Age Class: Mature  
SULE: Medium (15-40 years)

Retention Value: Low

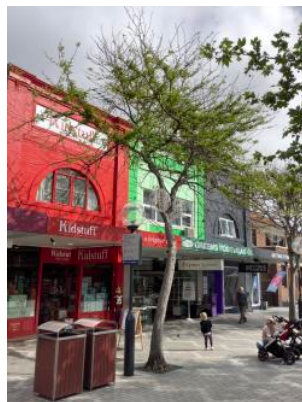
ID # 28  
Species: *Gleditsia triacanthos 'Shademaster'*  
Common: Honey Locust  
Height (m): 7.1  
DBH (m): 0.25 DGL (m): 0.37  
Current Form: Average  
Current Vigour: Fair  
Age Class: Mature  
SULE: Medium (15-40 years)

Retention Value: Low

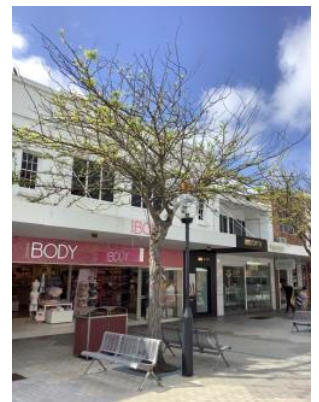
ID # 32  
Species: *Gleditsia triacanthos 'Shademaster'*  
Common: Honey Locust  
Height (m): 5.9  
DBH (m): 0.28 DGL (m): 0.38  
Current Form: Poor  
Current Vigour: Fair  
Age Class: Mature  
SULE: Short (5-15 years)

Retention Value: Low

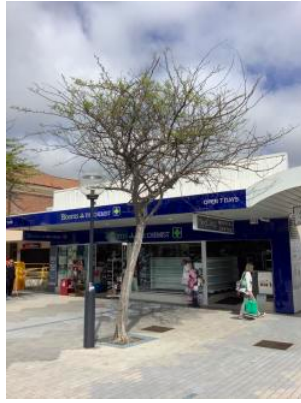
ID # 33  
Species: *Gleditsia triacanthos* 'Shademaster'  
Common: Honey Locust  
Height (m): 5.7  
DBH (m): 0.21 DGL (m): 0.31  
Current Form: Average  
Current Vigour: Fair  
Age Class: Mature  
SULE: Medium (15-40 years)

Retention Value: **Low**

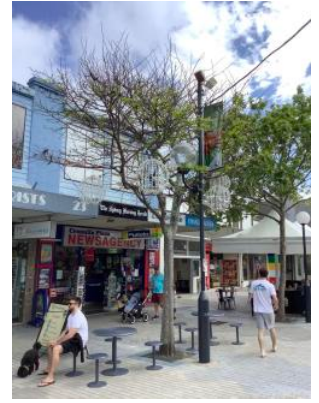
ID # 37  
Species: *Gleditsia triacanthos* 'Shademaster'  
Common: Honey Locust  
Height (m): 5.9  
DBH (m): 0.33 DGL (m): 0.35  
Current Form: Average  
Current Vigour: Fair  
Age Class: Mature  
SULE: Short (5-15 years)

Retention Value: **Low**

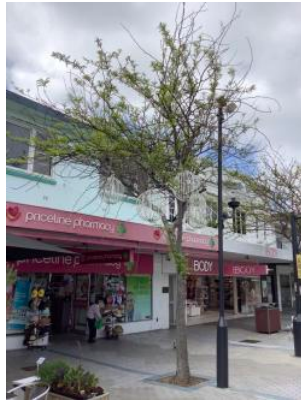
ID # 34  
Species: *Gleditsia triacanthos* 'Shademaster'  
Common: Honey Locust  
Height (m): 5.5  
DBH (m): 0.22 DGL (m): 0.30  
Current Form: Average  
Current Vigour: Fair  
Age Class: Mature  
SULE: Medium (15-40 years)

Retention Value: **Low**

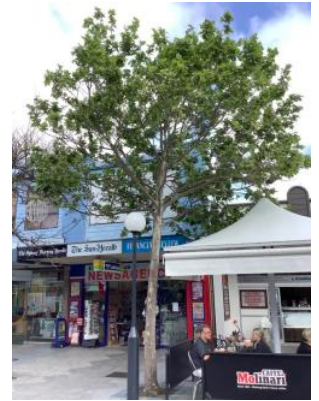
ID # 38  
Species: *Platanus x acerifolia*  
Common: London Plane  
Height (m): 6.5  
DBH (m): 0.21 DGL (m): 0.29  
Current Form: Good  
Current Vigour: Fair  
Age Class: Mature  
SULE: Medium (15-40 years)

Retention Value: **Low**

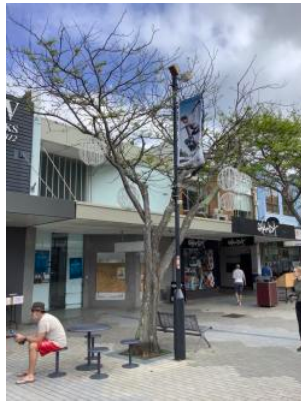
ID # 35  
Species: *Gleditsia triacanthos* 'Shademaster'  
Common: Honey Locust  
Height (m): 6.0  
DBH (m): 0.35 DGL (m): 0.45  
Current Form: Average  
Current Vigour: Fair  
Age Class: Mature  
SULE: Short (5-15 years)

Retention Value: **Low**

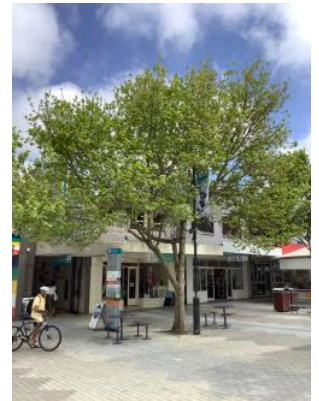
ID # 39  
Species: *Platanus x acerifolia*  
Common: London Plane  
Height (m): 8.0  
DBH (m): 0.34 DGL (m): 0.43  
Current Form: Average  
Current Vigour: Fair  
Age Class: Mature  
SULE: Medium (15-40 years)

Retention Value: **Low**

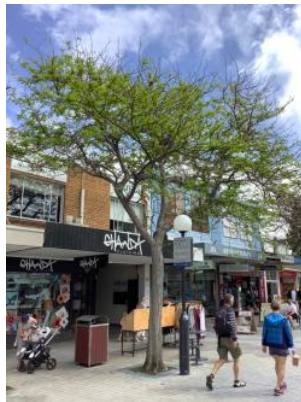
ID # 36  
Species: *Gleditsia triacanthos* 'Shademaster'  
Common: Honey Locust  
Height (m): 6.2  
DBH (m): 0.32 DGL (m): 0.44  
Current Form: Good  
Current Vigour: Fair  
Age Class: Mature  
SULE: Medium (15-40 years)

Retention Value: **Moderate**

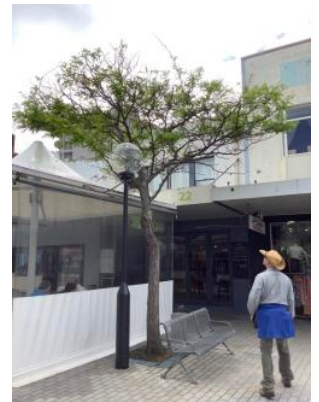
ID # 40  
Species: *Gleditsia triacanthos* 'Shademaster'  
Common: Honey Locust  
Height (m): 4.8  
DBH (m): 0.20 DGL (m): 0.28  
Current Form: Average  
Current Vigour: Poor  
Age Class: Mature  
SULE: Short (5-15 years)

Retention Value: **Low**

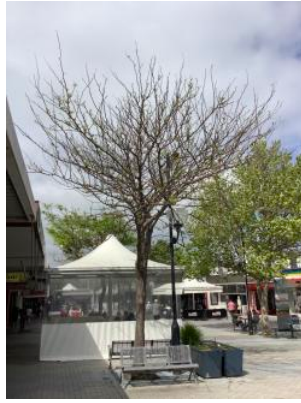
ID # 41  
Species: *Gleditsia triacanthos* 'Shademaster'  
Common: Honey Locust  
Height (m): 6.1  
DBH (m): 0.26 DGL (m): 0.34  
Current Form: Average  
Current Vigour: Fair  
Age Class: Mature  
SULE: Medium (15-40 years)

Retention Value: **Low**

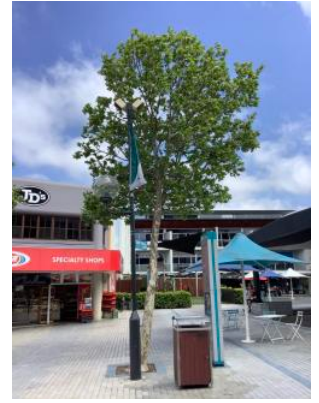
ID # 45  
Species: *Platanus x acerifolia*  
Common: London Plane  
Height (m): 8.2  
DBH (m): 0.22 DGL (m): 0.27  
Current Form: Good  
Current Vigour: Fair  
Age Class: Mature  
SULE: Medium (15-40 years)

Retention Value: **Moderate**

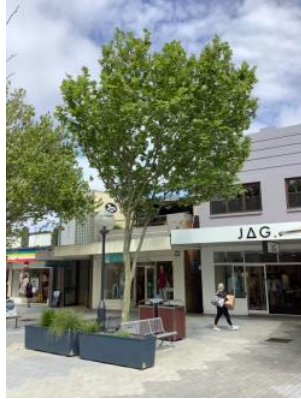
ID # 42  
Species: *Platanus x acerifolia*  
Common: London Plane  
Height (m): 7.8  
DBH (m): 0.19 DGL (m): 0.25  
Current Form: Average  
Current Vigour: Good  
Age Class: Mature  
SULE: Medium (15-40 years)

Retention Value: **Moderate**

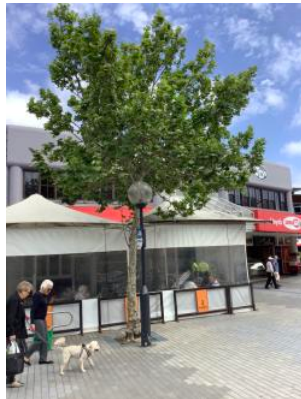
ID # 43  
Species: *Platanus x acerifolia*  
Common: London Plane  
Height (m): 7.6  
DBH (m): 0.20 DGL (m): 0.32  
Current Form: Average  
Current Vigour: Fair  
Age Class: Mature  
SULE: Medium (15-40 years)

Retention Value: **Low**

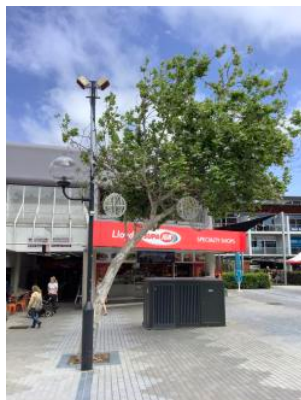
ID # 44  
Species: *Platanus x acerifolia*  
Common: London Plane  
Height (m): 7.2  
DBH (m): 0.24 DGL (m): 0.36  
Current Form: Poor  
Current Vigour: Fair  
Age Class: Mature  
SULE: Short (5-15 years)

Retention Value: **Low**

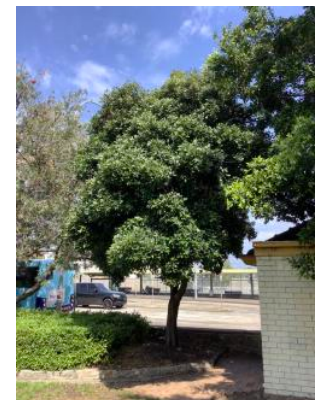
ID # 48  
Species: *Cinnamomum burmannii*?  
Common: Padang Cassia  
Height (m): 6.4  
DBH (m): 0.28 DGL (m): 0.31  
Current Form: Good  
Current Vigour: Good  
Age Class: Mature  
SULE: Long (>40 years)

Retention Value: **Moderate**
