MEMORANDUM

REQUEST FOR PLANNING PROPOSAL 251, 260R, 278 AND 280-282 CAPTAIN COOK DRIVE, KURNELL

Author(s)	Sunil Shrestha
Entity	Civil - Brownfields
Version	V07
Reference	Request for Planning Proposal 251, 260R, 278 and 280-282 Captain Cook Drive, Kurnell

This memorandum has been prepared by Egis on behalf of Besmaw Pty Ltd, the proponent of the Kurnell Planning Proposal, to address comments from various agencies and departments regarding the Stormwater Management Plan V05 and the Hydrology and Hydraulic Analysis submitted by Egis Group on 6 March 2024.

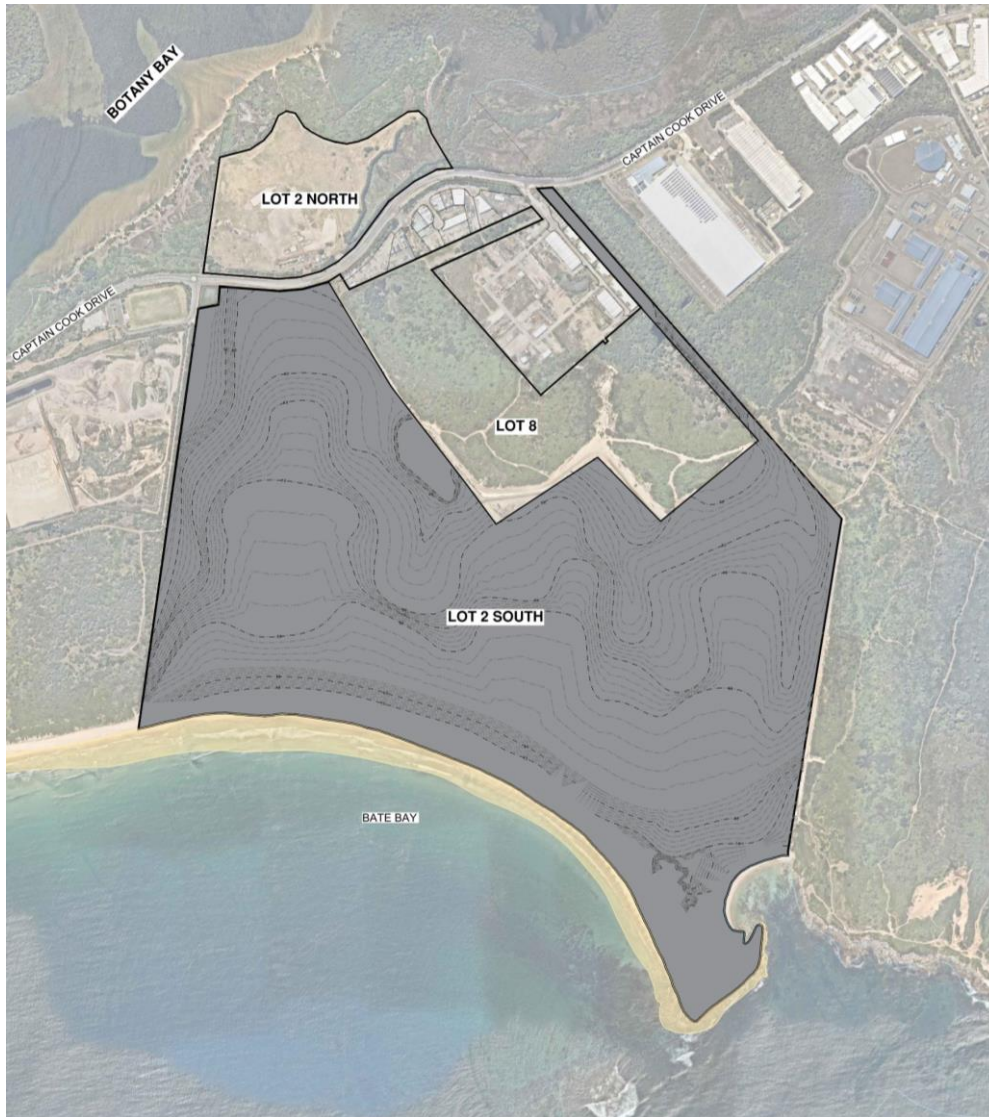
The indicative rehabilitated landform on Lot 2 south is outlined below.

- Lot 2 North as it exists today.
- Lot 8 and Lot 9 as they exists today.
- Lot 2 South following the completion of sand extraction and replacement of VENM, is graded so that surface runoff is directed and discharged northwards into Botany Bay or directed into the sand environment along the southern, eastern and western boundaries of the site, infiltrating to recharge the freshwater aquifer, with the terrain consistent with the 'developed' scenario.

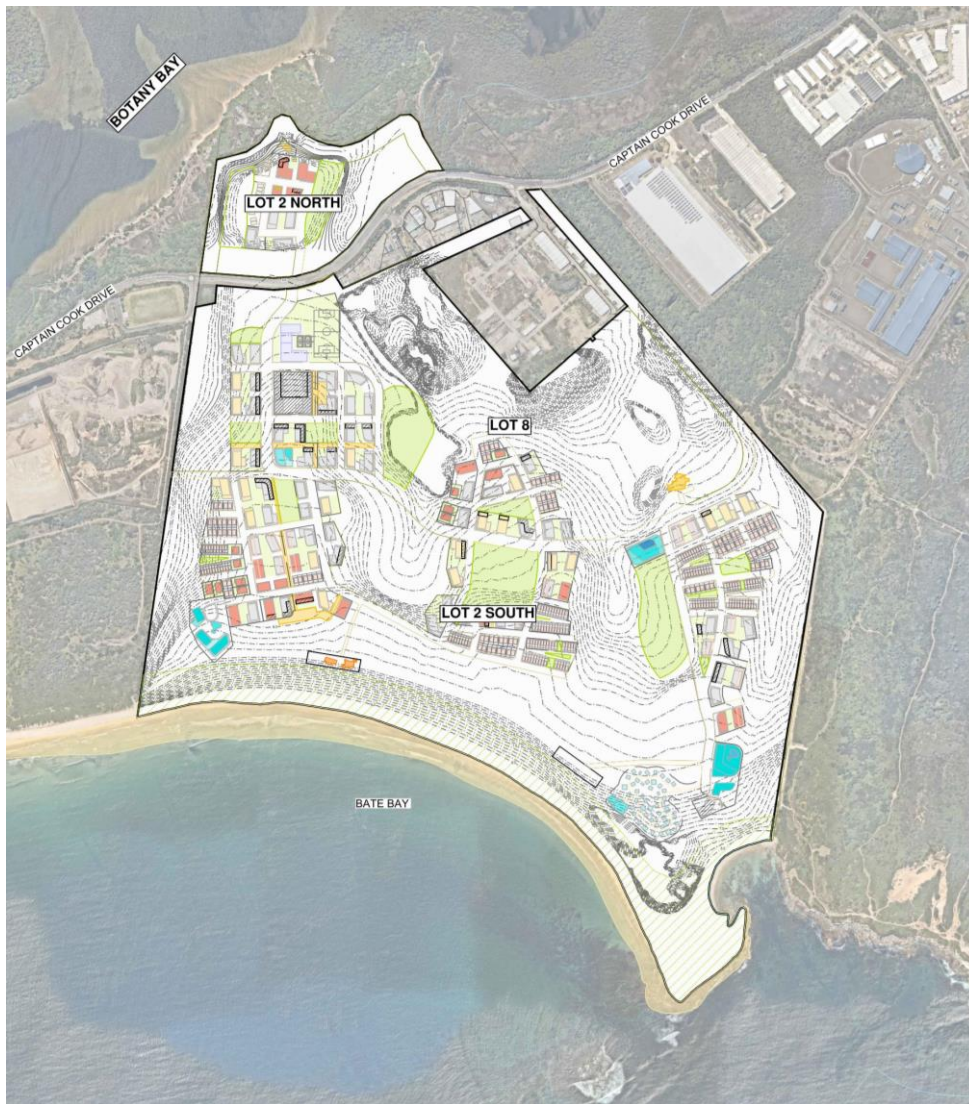
An extract from Appendix A of Stormwater Management Report V06 outlining the proposed developed case landform for the entire site is outlined below.

The 'developed' scenario represents the final landform post-rehabilitation of 'Lot 2 South', 'Lot 2 North' and Lot 8, incorporating site levels for future building footprints.

- Lot 9 as it exists today
- Lot 2 South following the completion of sand extraction and replacement of VENM, is graded so that surface runoff is directed and discharged northwards into Botany Bay or directed into the sand environment along the southern, eastern, and western boundaries of the site, infiltrating to recharge the freshwater aquifer; and

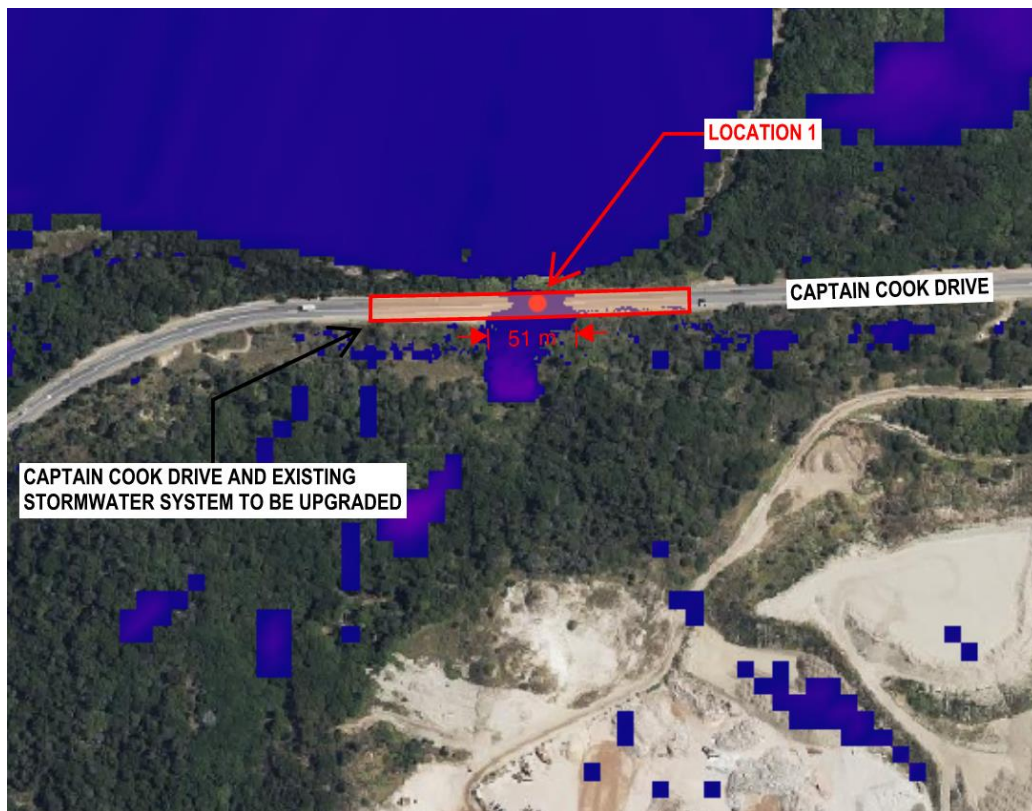
FIGURE 1: CAPTAIN COOK DRIVE UPGRADE (LOCATION 1)

Location 1 is shown in Figure 1 above and is located Northwest of the proposed development site. It would form a part of the access route during flood events. As part of the upgrade works, Captain Cook Drive and the existing stormwater system would need to be upgraded to minimise the effects of flood and ensure safe access during larger storm events.

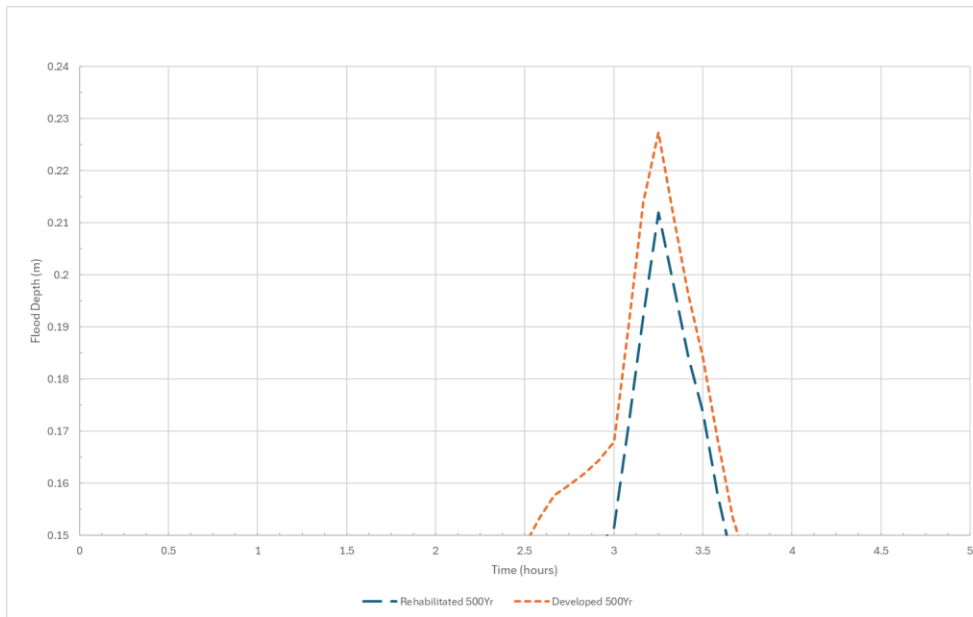
FIGURE 2: TIME OF INUNDATION – LOCATION 1 (0.2% AEP)

Figures 2 and 3 provide graphical representations for the depth vs time investigation at Location 1 during the 500 year and PMF events. The criterion for inundation is depths equal to or greater than 150mm.

The time of inundation for the rehabilitated scenario is approximately 30 minutes for the critical 0.2% AEP flood event and approximately 5 hours for the PMF event. The time of inundation for the developed scenario is almost 1.5 hrs for the 0.2% AEP flood event and mimics that of the rehabilitated case for the PMF event.

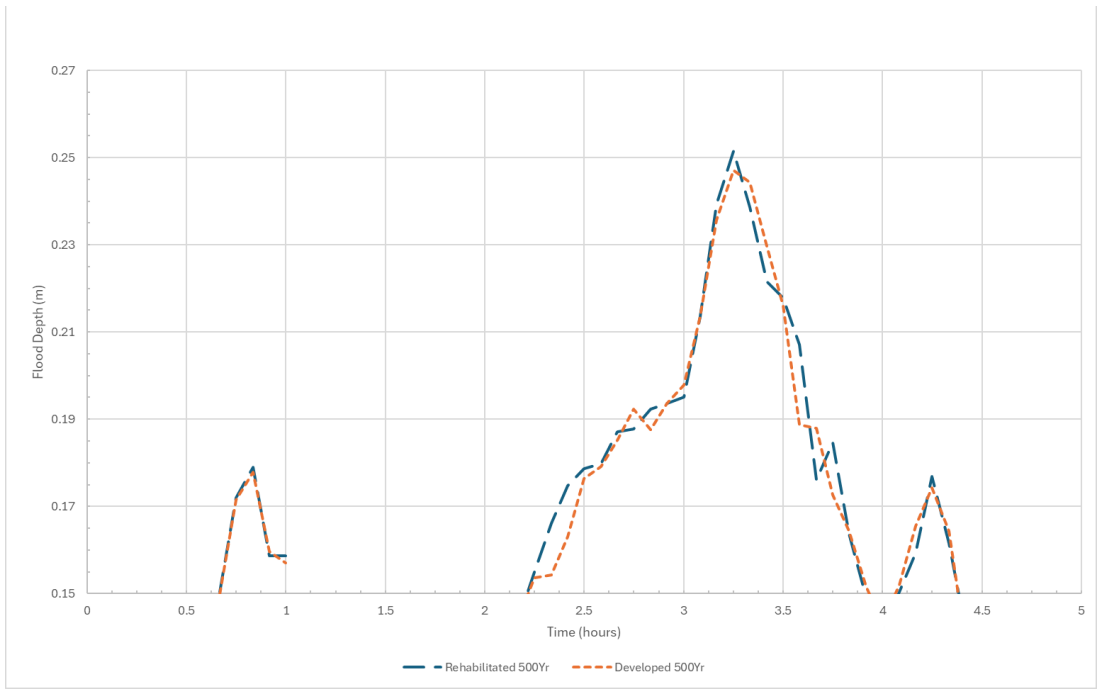
FIGURE 4: TIME OF INUNDATION – LOCATION 1 (0.2% AEP) WITH CLIMATE CHANGE AND SLR

Additionally, the impacts of Sea Level Rise and Climate Change have been considered as part of the inundation analysis in Figures 4 and 5. The results of the 0.2% AEP event for both rehabilitated and developed scenarios show that the time of inundation increased to almost 2 hours. However, the impacts of Sea Level Rise and Climate Change are very minor for the PMF event.

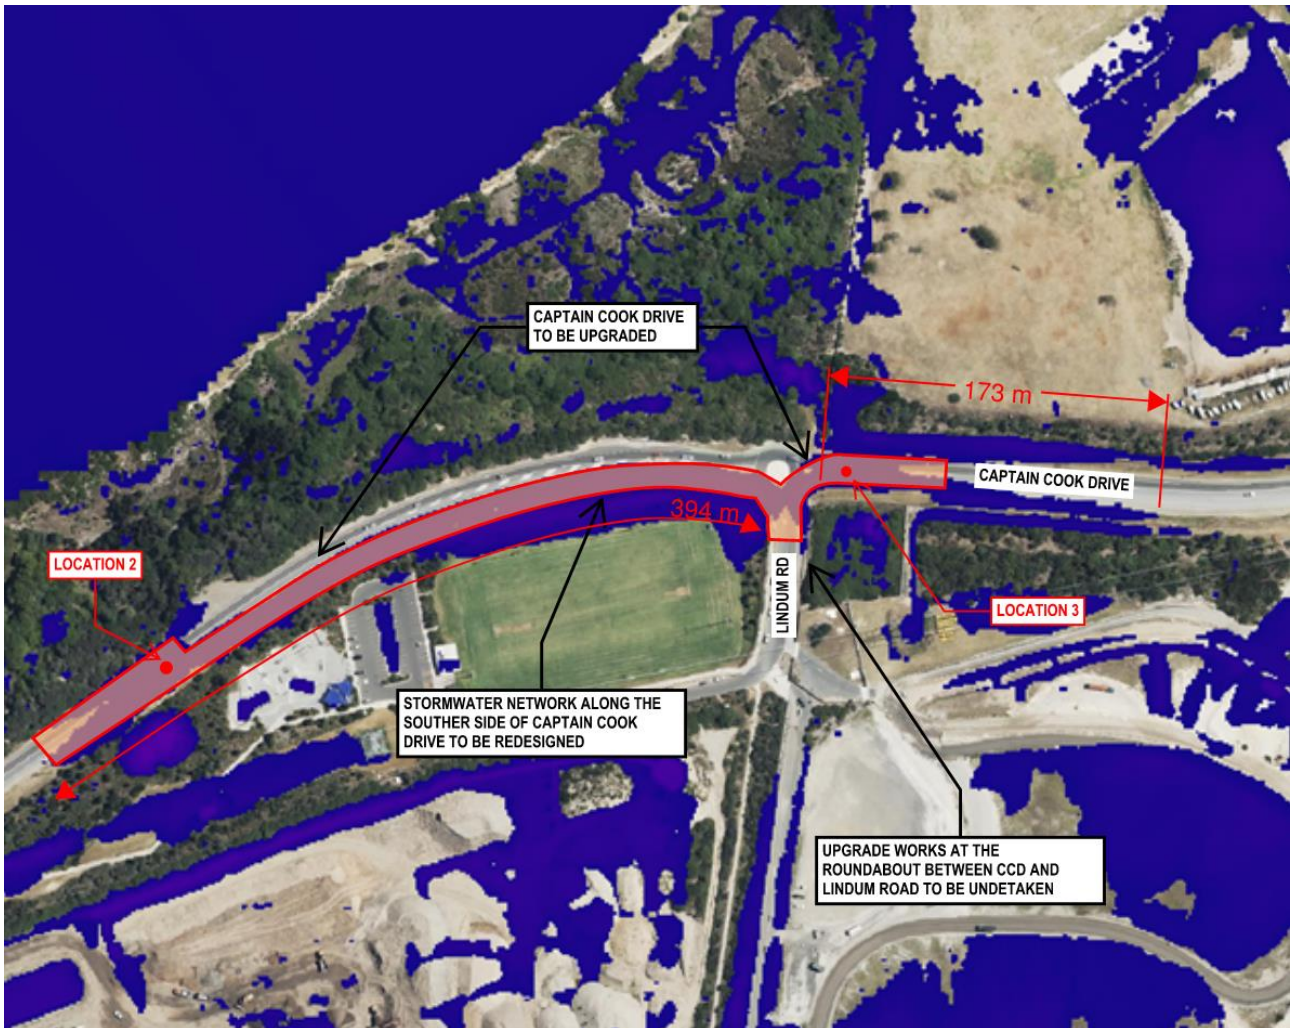
FIGURE 6: CAPTAIN COOK DRIVE UPGRADE (LOCATION 2 AND 3)

Figure 6 shows the section of Captain Cook Drive directly Northwest of the proposed site. This area includes the northern portion of Lindum Road and the roundabout connecting it to Captain Cook Drive. Location 2 consists of approximately 394 metres of Captain Cook Drive west of the roundabout. Location 3 consists of approximately 173 metres of Captain Cook Drive to the east of the roundabout.

The upgrade works would include modification of the existing stormwater system along the southern side, including the roundabout, as well as upgrade to Captain Cook Drive itself.

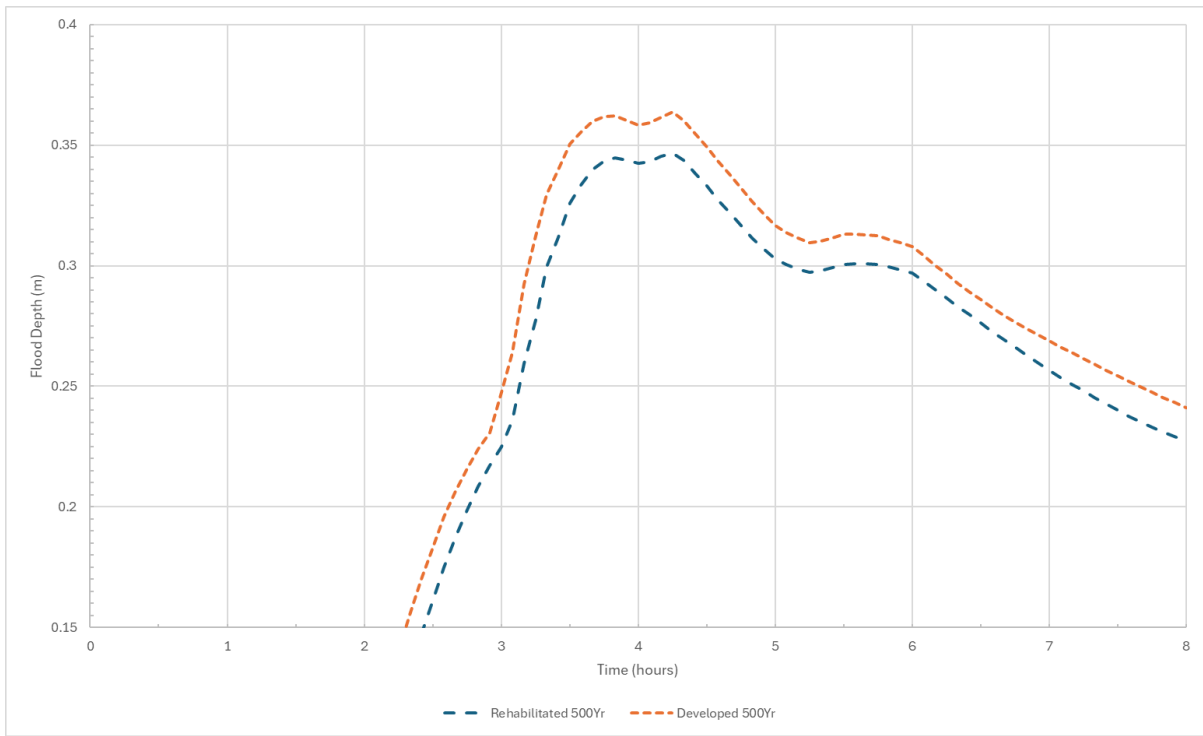
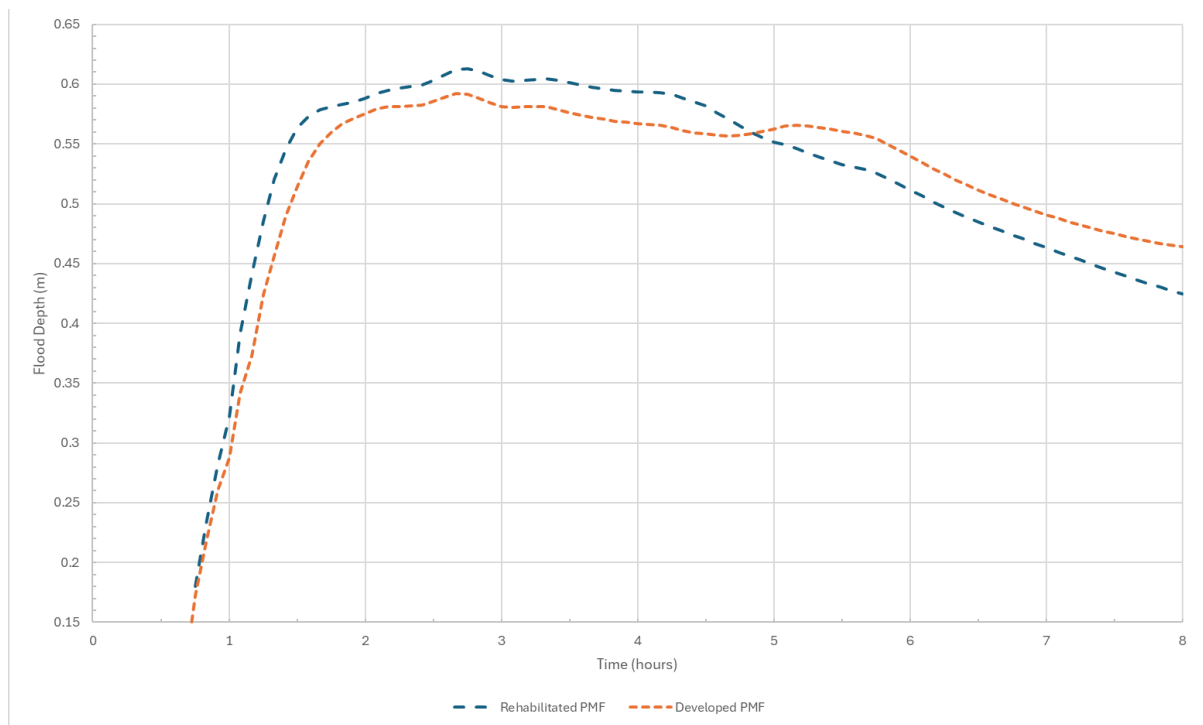
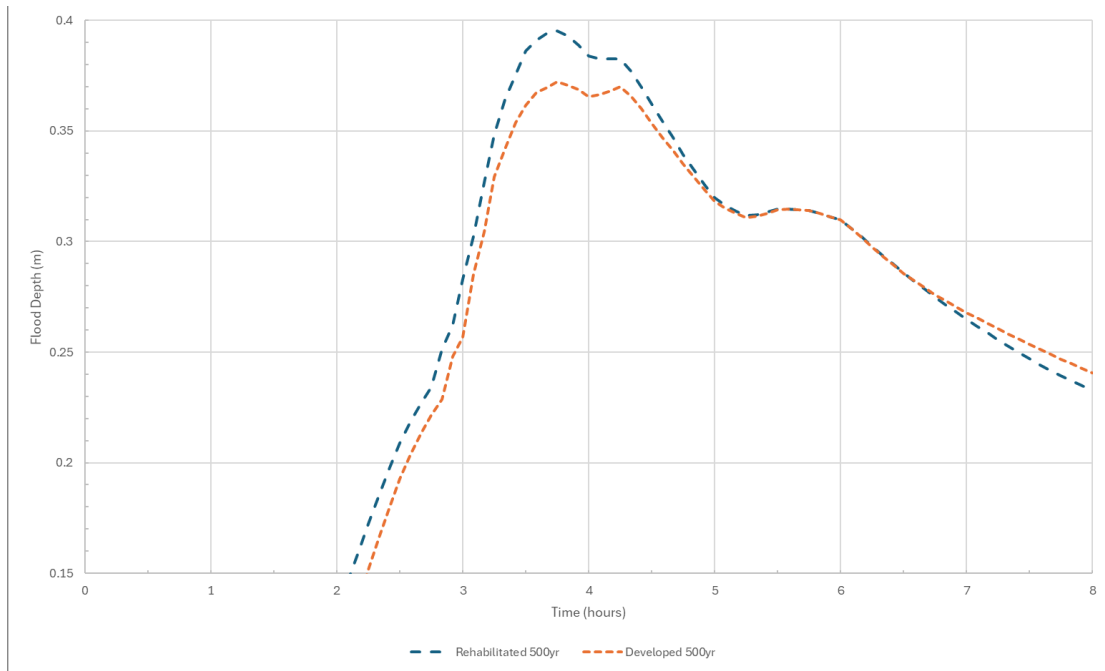
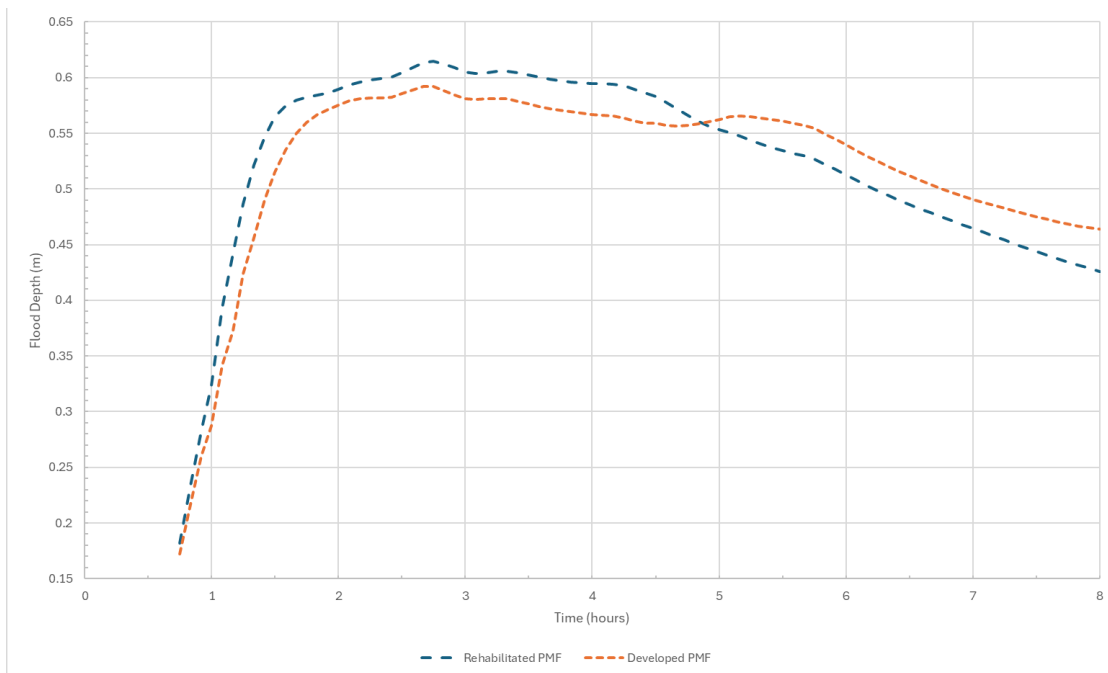
Figures 7-10 provides graphical representations for the depth vs time investigation of Location 2 and Figures 11-14 provide the graphs for Location 3, during the 500 year and PMF events.

For location 2, the time of inundation for flood depths greater than 150mm is 6 hours or greater for the 0.2% AEP event with a greater period of inundation for the PMF flood. This is seen to be the case for both the rehabilitated and developed scenarios. The proposed upgrade works for Captain Cook Drive and the existing stormwater system will serve to ensure that the flood depth is reduced so that the road will be trafficable by high-clearance emergency vehicles.

Considering the effects of Sea Level Rise and Climate Change, the maximum flood depths for the 0.2% AEP event was increased by approx. 8mm for the developed case, and the results were very similar for the PMF storm event.

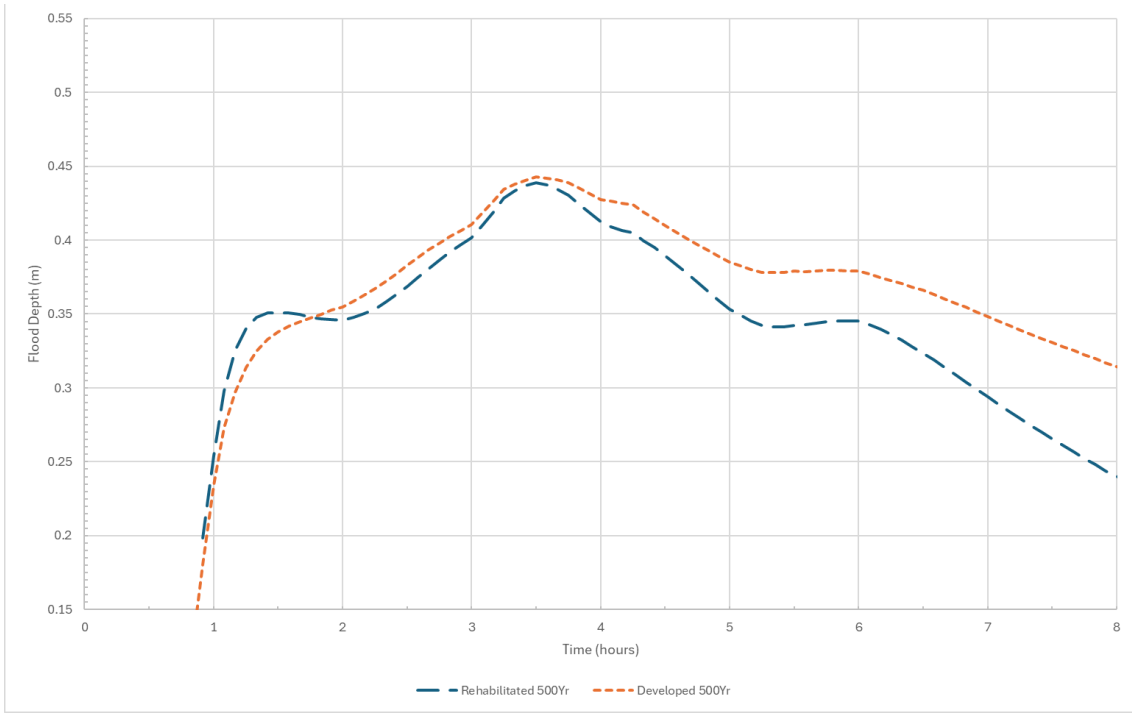
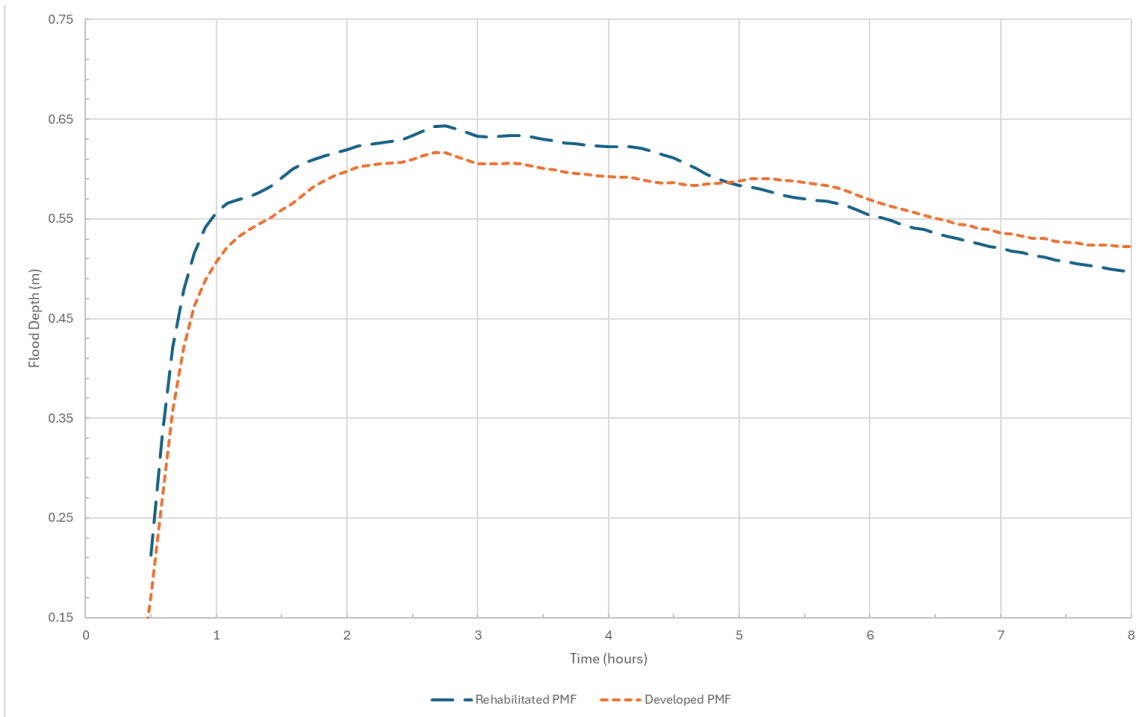
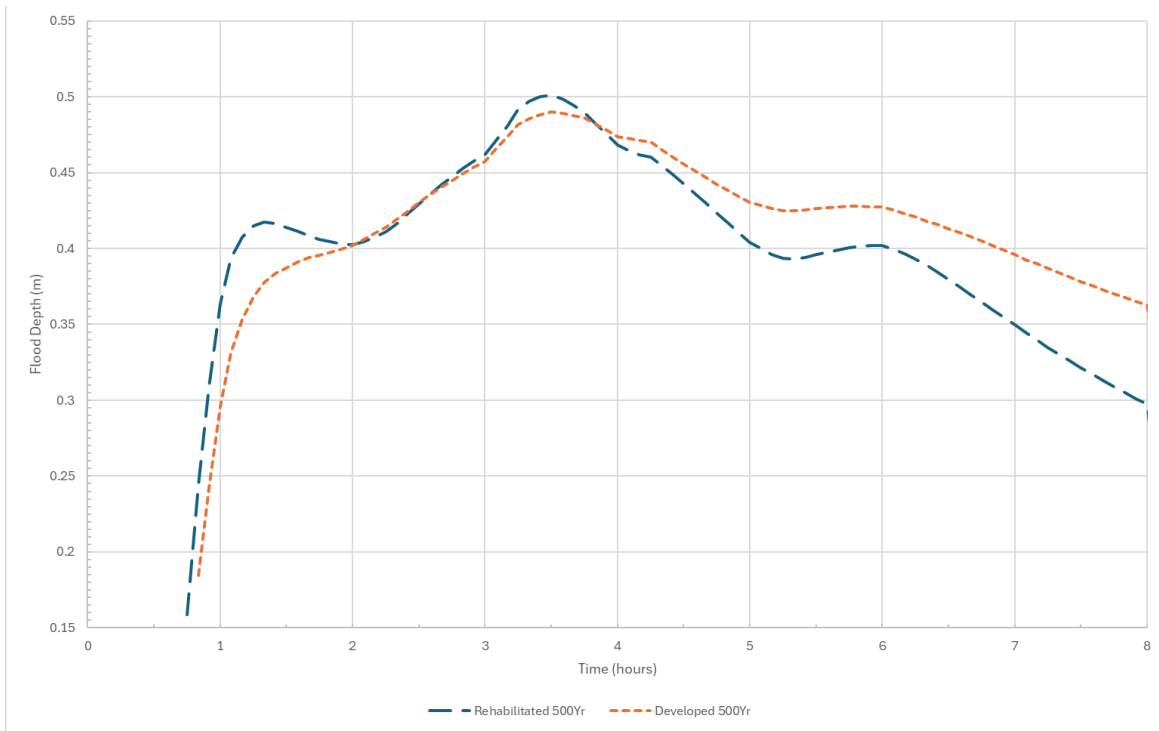
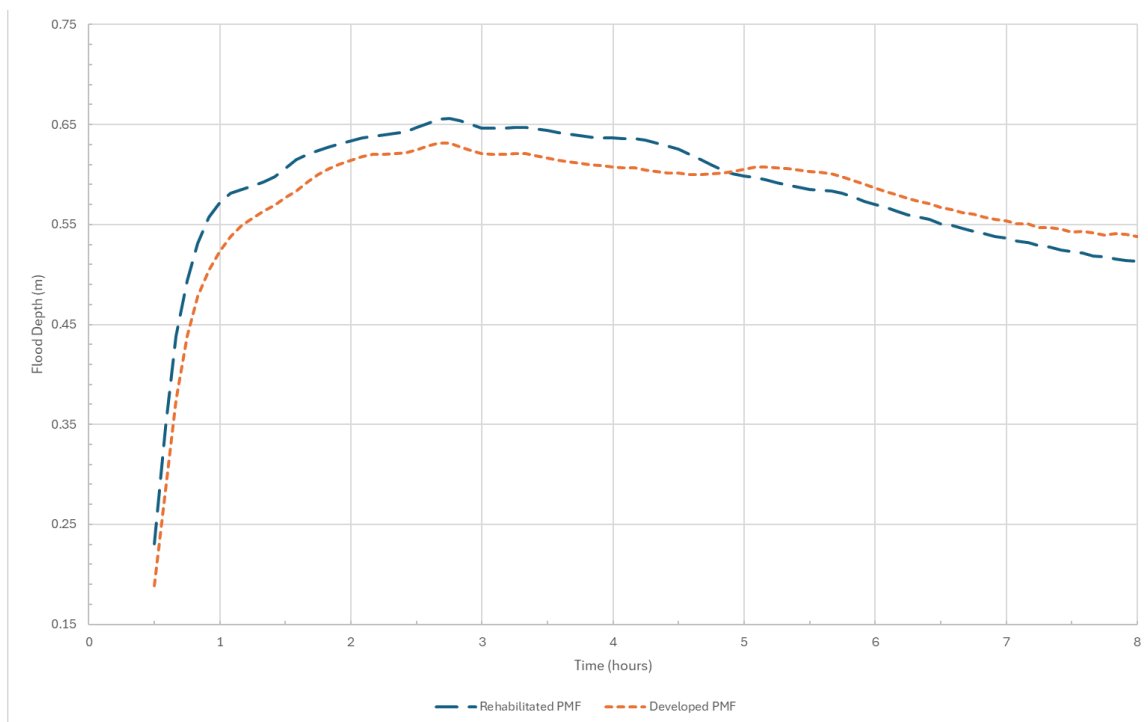
For location 3, the time of inundation of greater than 150mm is 7 hours or greater for the 0.2% AEP event, for both rehabilitated and developed scenario. The results show that the impacts of the developed scenario are not significant as this section of CCD has higher flood depths even in the base case. However, upgrades to CCD would be required to ensure access to and from the site, for both scenarios. Similarly, for the PMF event, the maximum flood depth has been reduced in the developed cases, with extended periods of inundation seen in both scenarios.

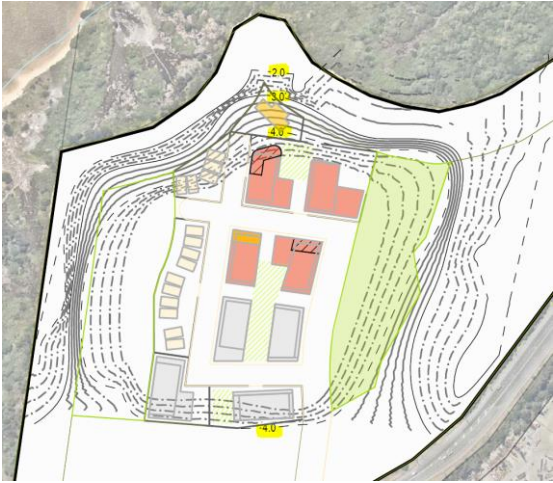
<p>Inconsistencies in reporting on degree of flood risk</p>	
<ul style="list-style-type: none"> • The Coastal Management Plan indicates a predicted 2120 storm near shore level of 2.6m AHD. The survey shows that most of Lot 2 North is at around 2m therefore it would be subject to coastal inundation unless significant fill is used. While the levels of Captain Cook Drive are not shown on the survey, it may also be impacted by coastal inundation. 	<ul style="list-style-type: none"> • It is proposed to fill Lot 2 North. Proposed design contours demonstrate that Lot 2 North is higher than 2.6m AHD and most of the buildings are above 4.0m AHD as outlined below:
